**Structural Collapse at
Dwelling Fire Results in
Two Firefighter Fatalities**

Stockton, California

February 1997

This is Report 102 of the Major Fires Investigation Project conducted by Varley-Campbell and Associates, Inc./TriData Corporation under contract EMW-94-4423 to the United States Fire Administration, Federal Emergency Management Agency.

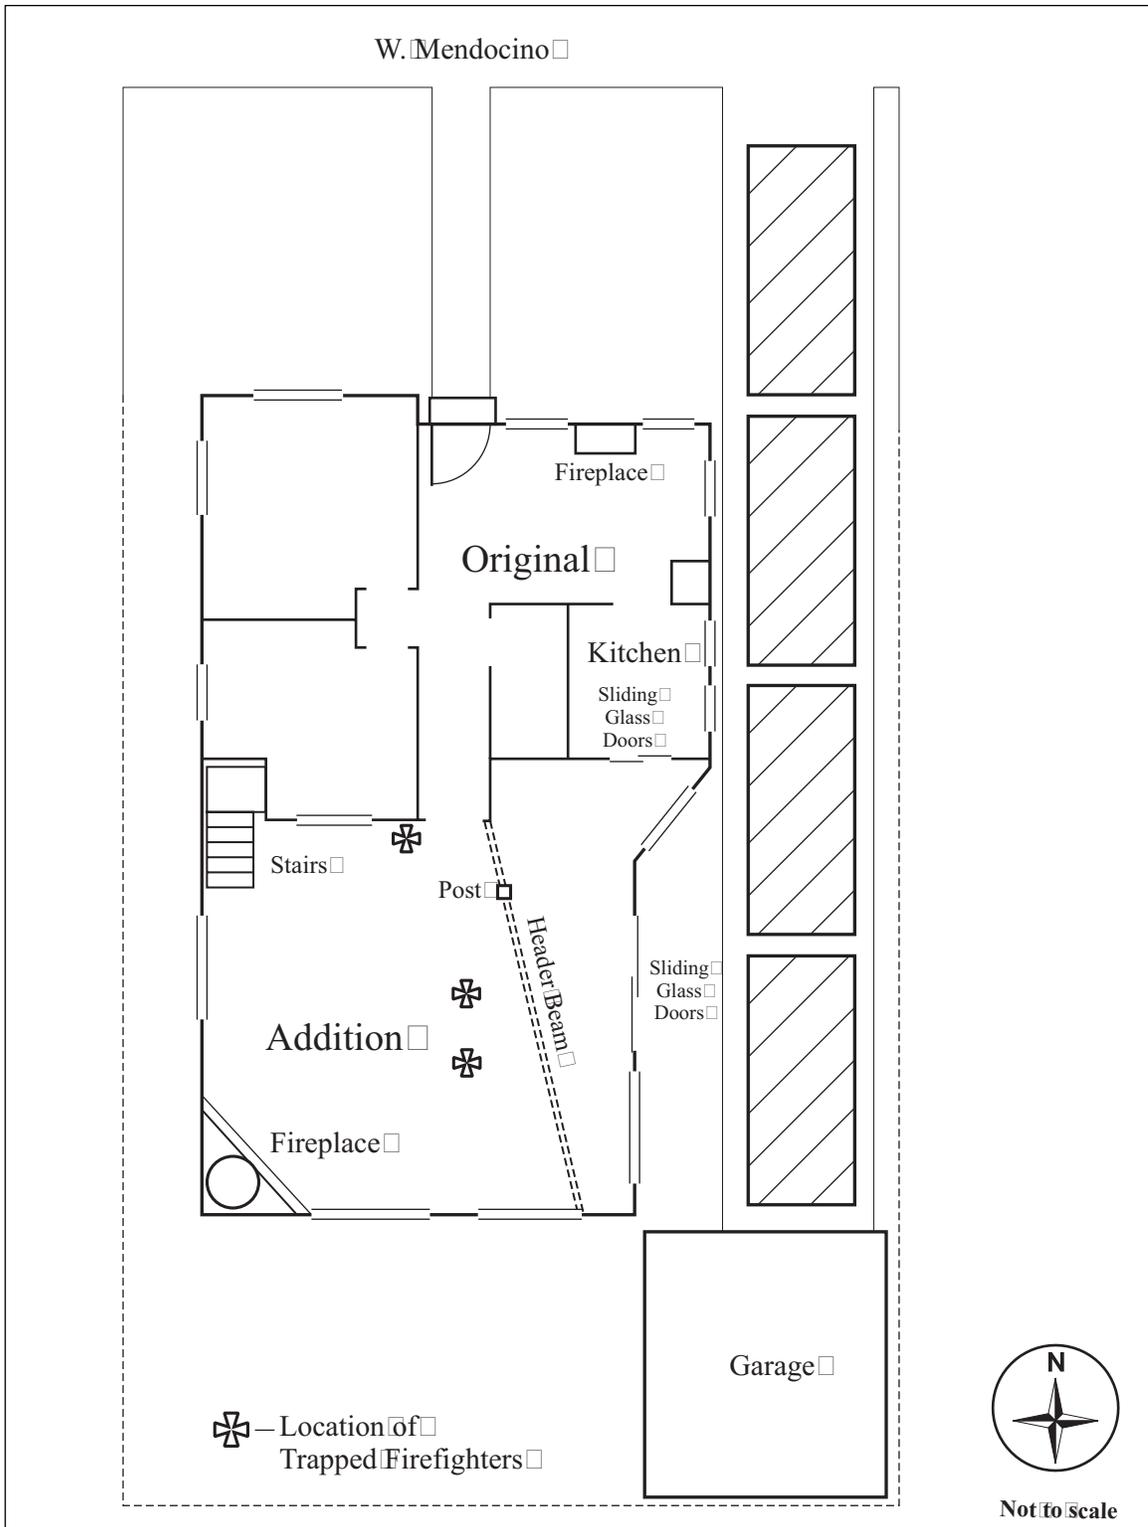
Figure 2 - Floor Plan - First Floor

The E6 Captain and one of the firefighters then deployed a standpipe pack to advance a back-up line into the interior. While the other firefighter fed the line from the door, the Captain advanced the 1-3/4 inch line toward the rear of the house. Noting that Engine 9[□] line had gone to the right, he took the back-up line toward the left side of the house, where fire was visible in the kitchen area. (See Figure 2)

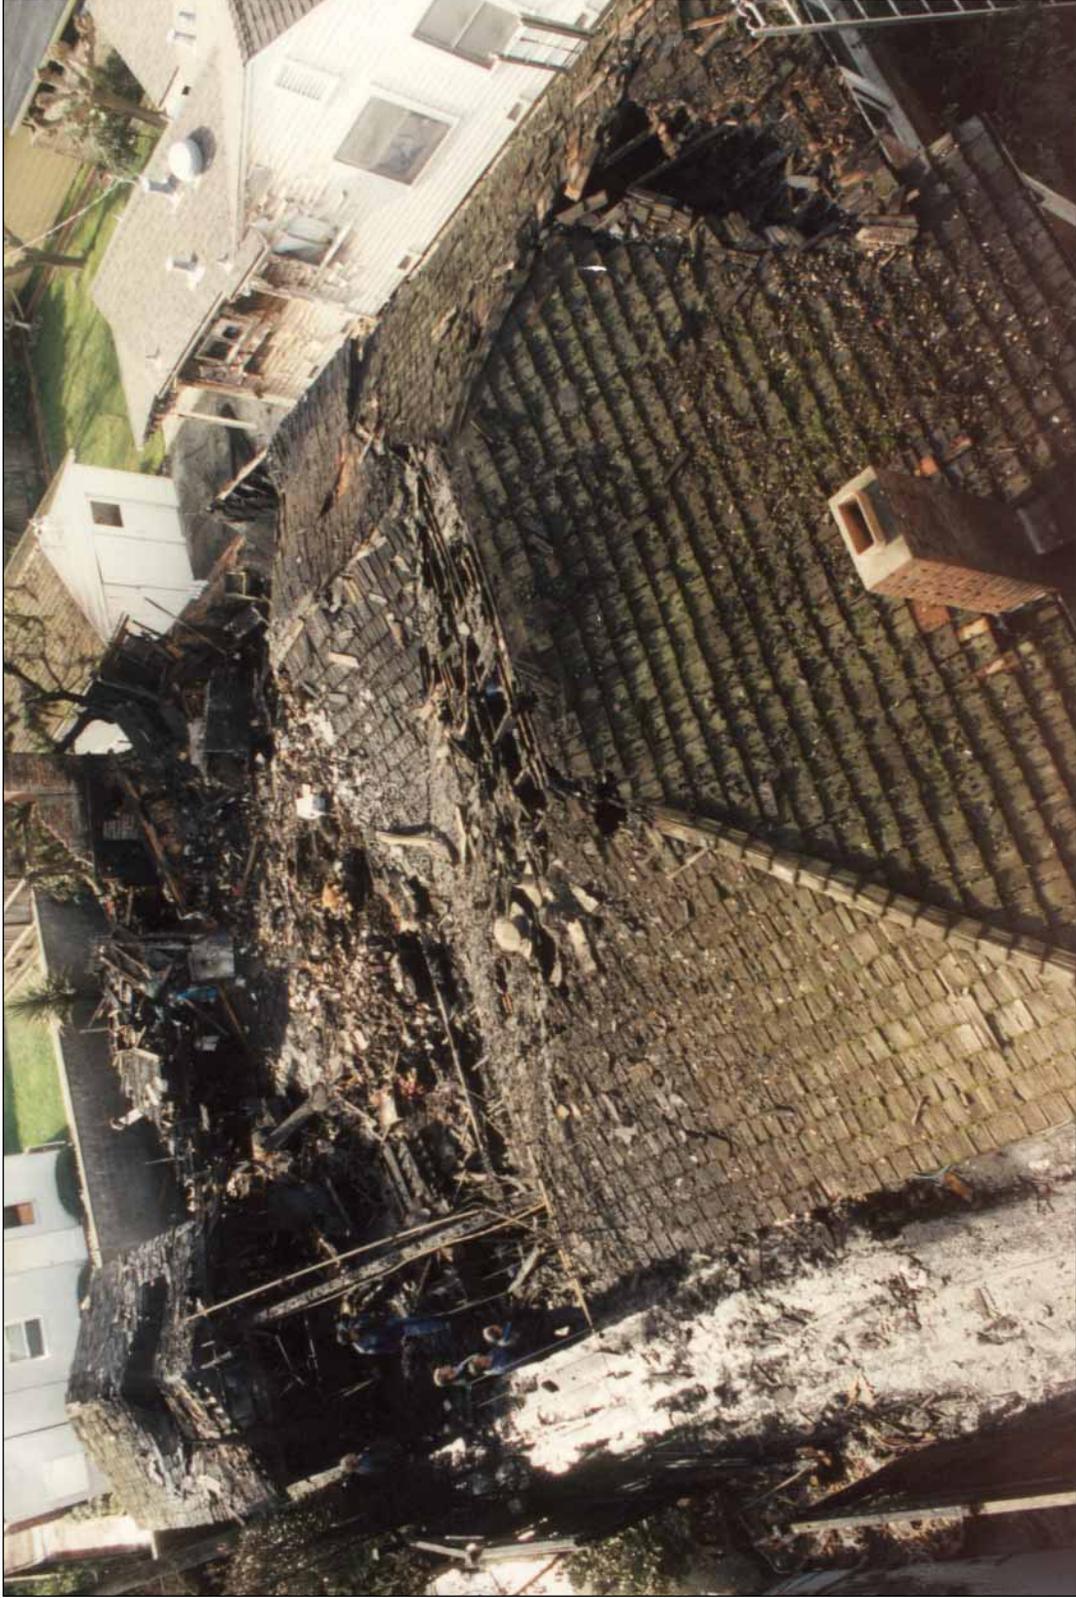
Analysis of the structure indicated that the heavy second floor was inadequately supported and vulnerable to the type of catastrophic collapse that occurred. The direct cause of the collapse was attributed to either a failure of the 4x6 support post within the room or the failure of the header beam itself.

2. Looking South Towards Rear of House □ Note Area of Second Floor Collapse

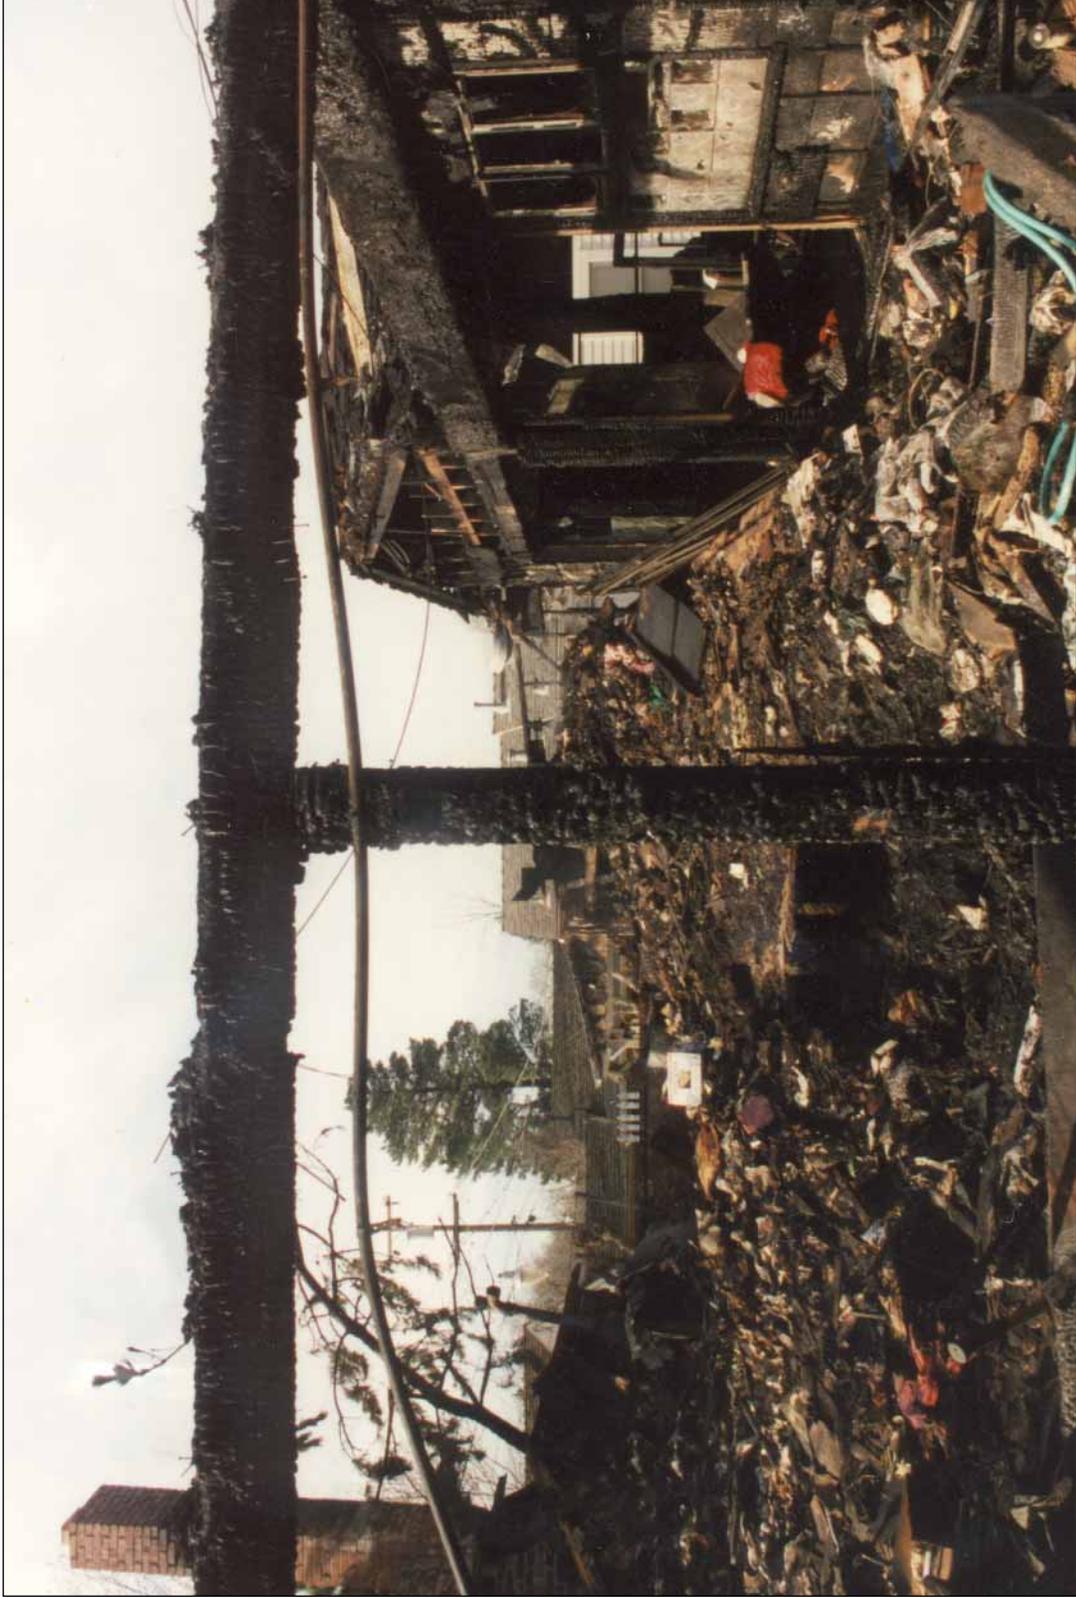
4. Looking Southwest, Across Back Room Addition, From the Driveway. The Original House is On the Right Side of the Photograph
