U.S. Fire Administration/Technical Report Series

Multiple Fatality Single-Family Dwelling Fire

St. Cloud, Florida

USFA-TR-142/March 2004

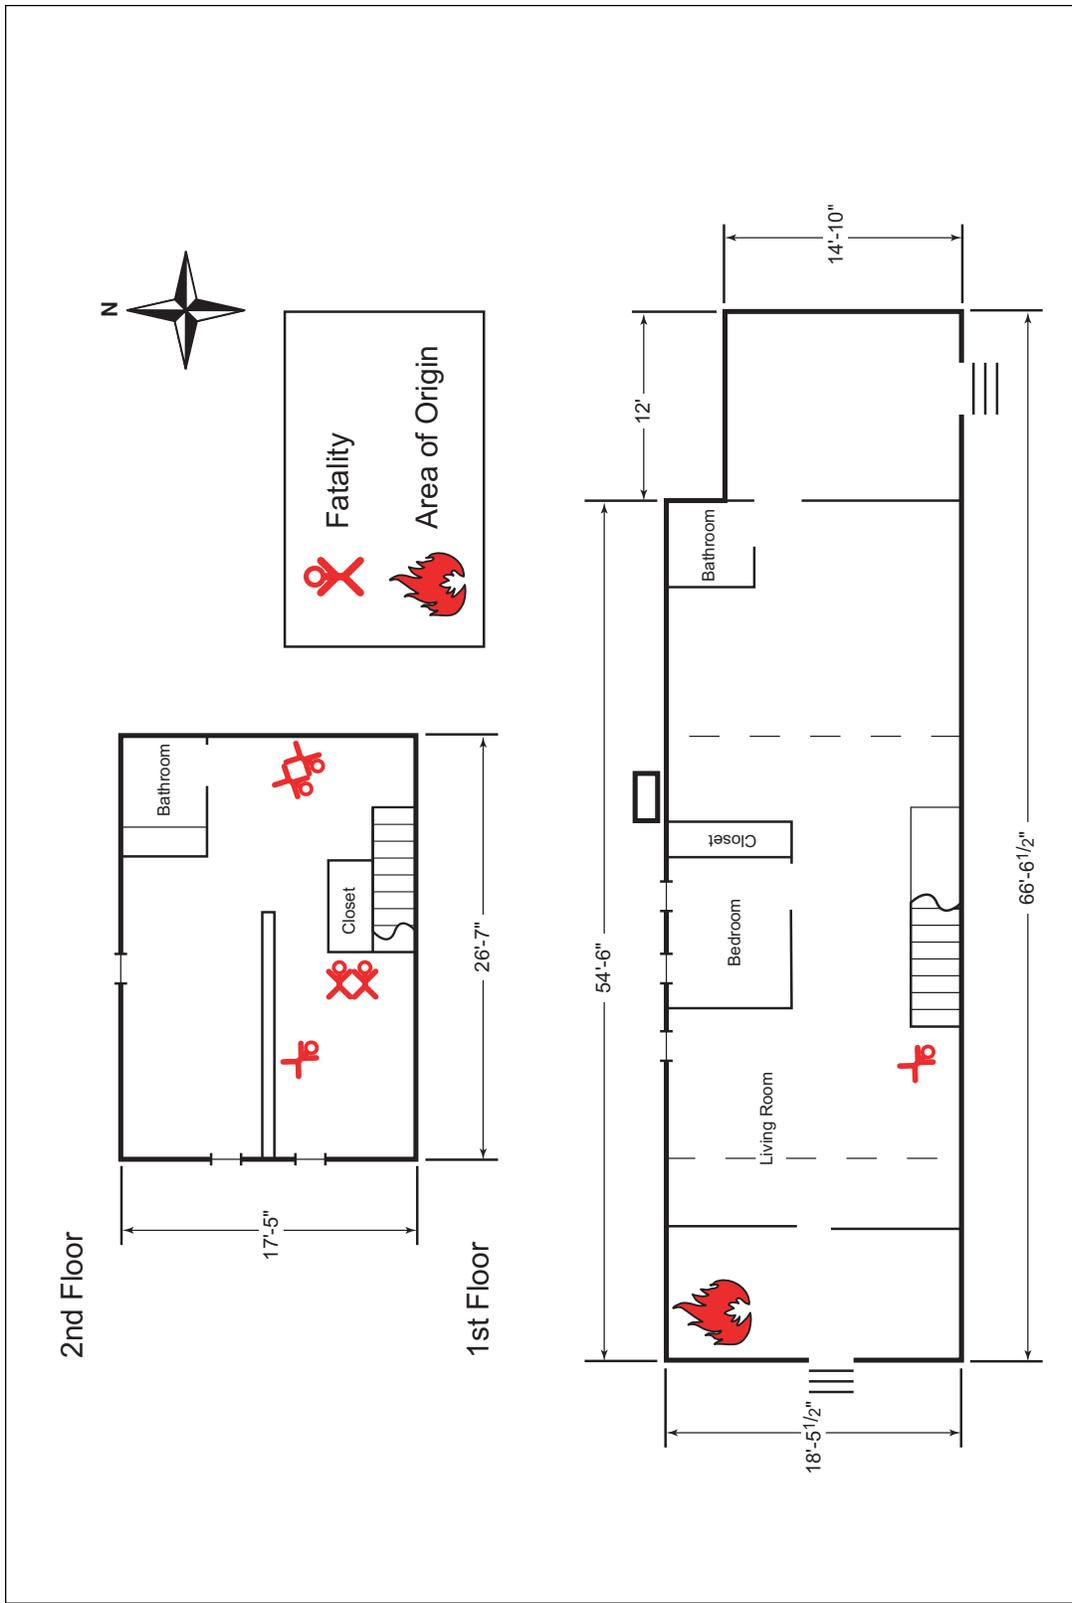
Diagram One: Sketch of the Floor Plan

The firefighters knocked down the fire on the second floor and discovered what they initially thought was two victims. Upon entering the second bedroom, firefighters found two more bodies by the rear window (see diagram 1 for the location of the victims, page A4). At this point, the IC requested that the department's Chaplin, the Medical Examiner from Orange County; the state fire marshal; and the local fire marshal be dispatched to the incident.

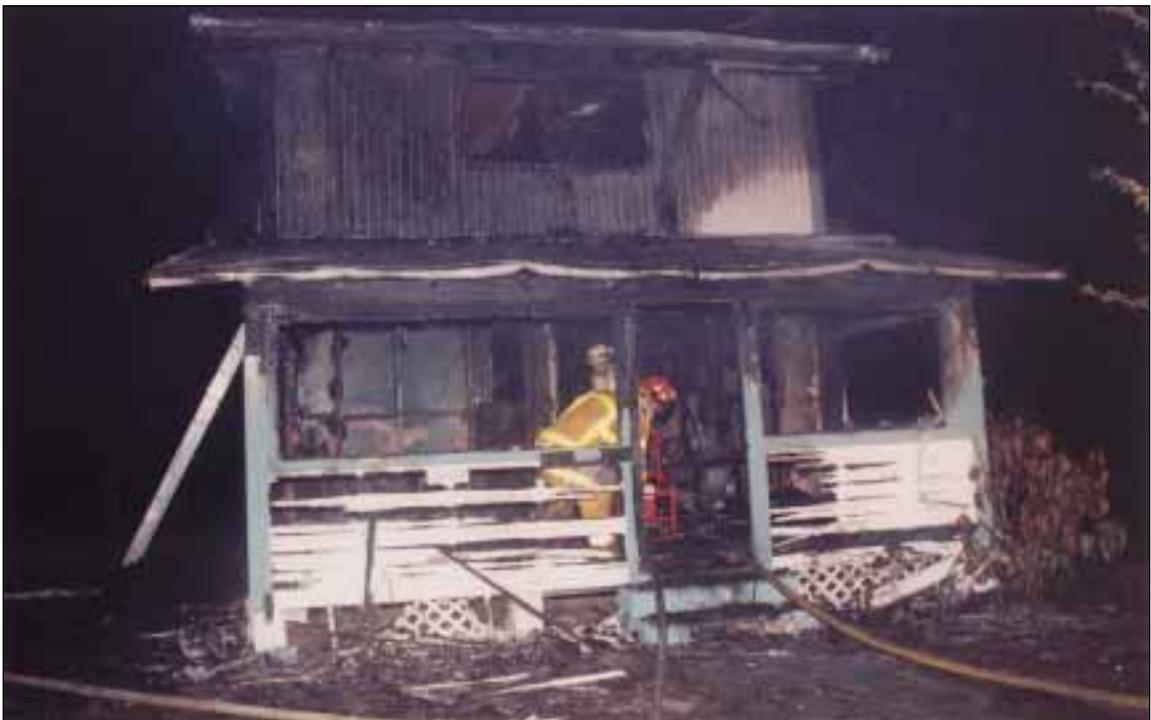
#2 Night view of front entrance on west side of house; note firefighters and

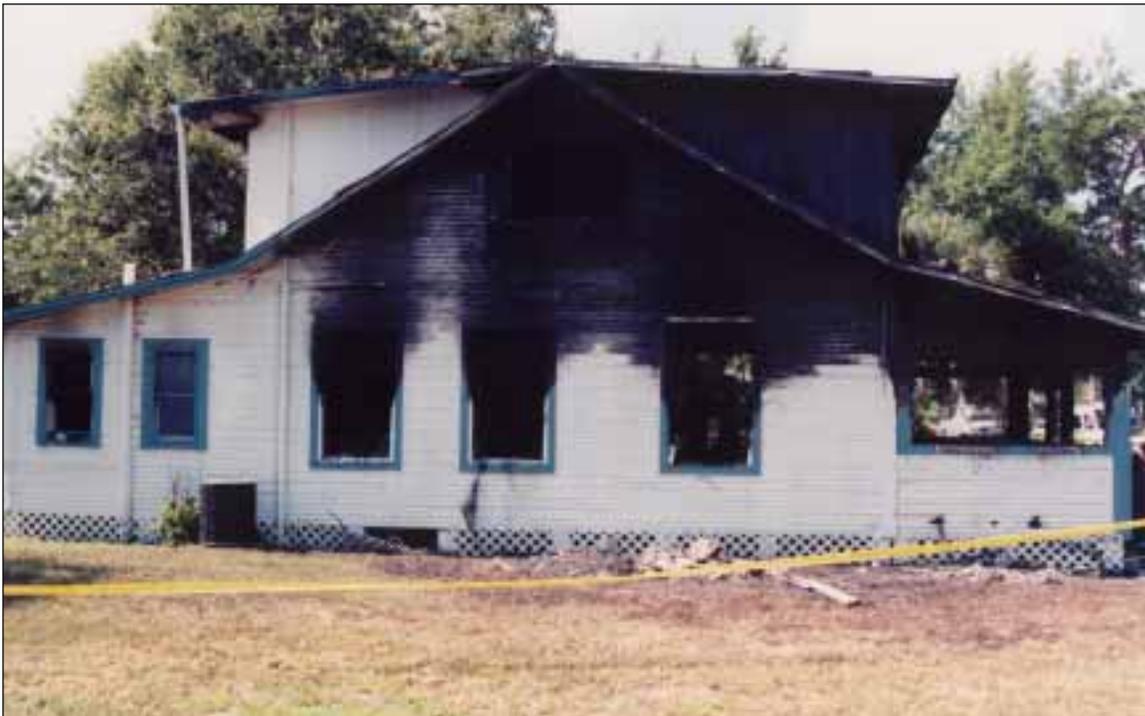
4 View of north side of house; note multiple roof lines indicating possible enlargement of second floor

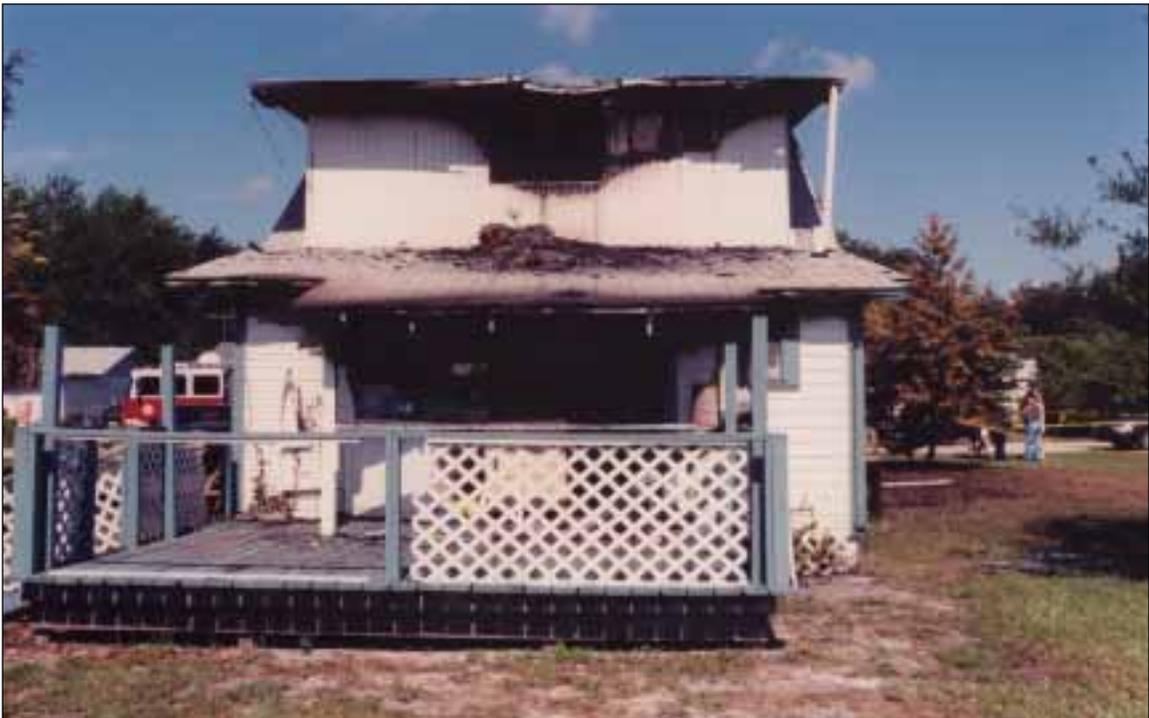
6 Day time view of rear of house and open back porch; note: this is where male occupant climbed up and broke out rear window and called for children; two bodies located just inside the rear window on second floor.

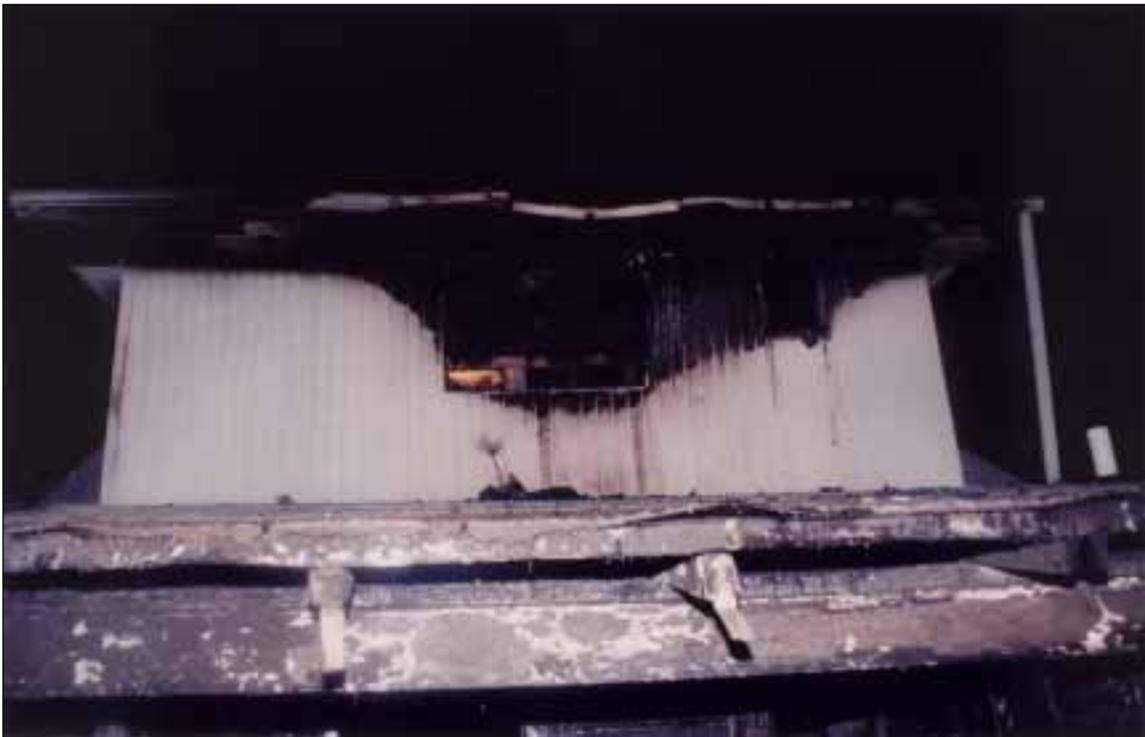
#8 Exterior view of second floor window of rear bedroom; note charring pattern

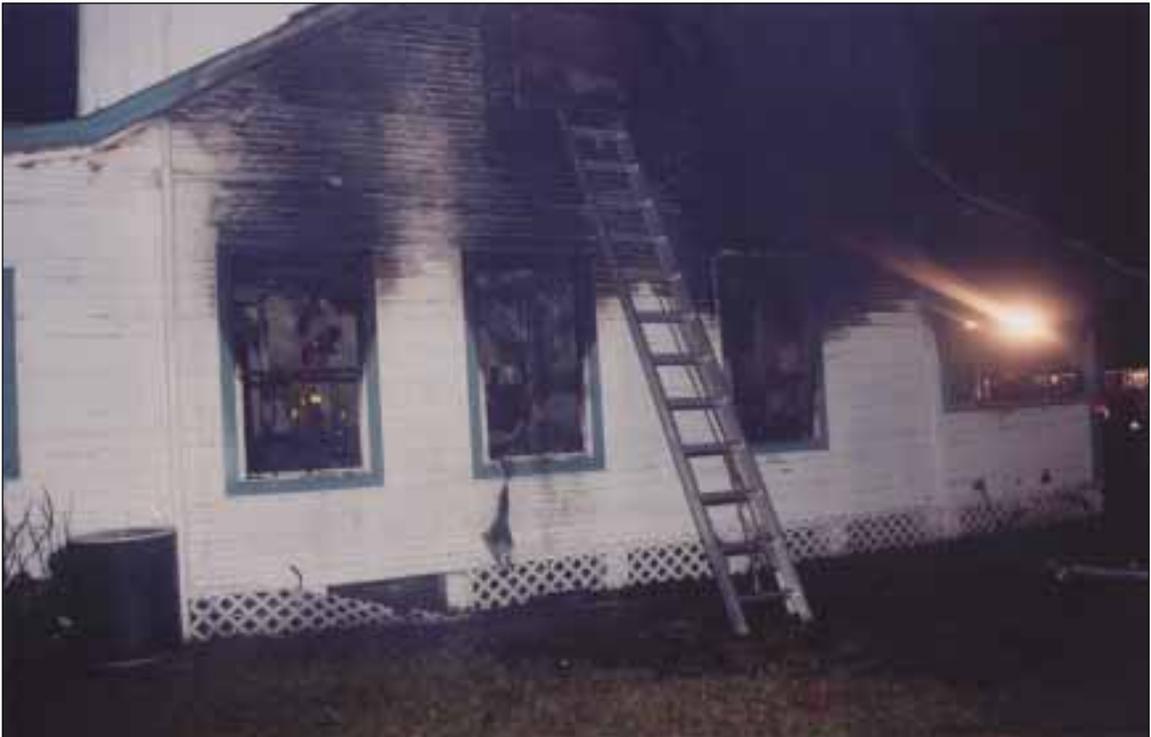
#10 Another view of north wall off house; note ladder and char patterns above all three windows

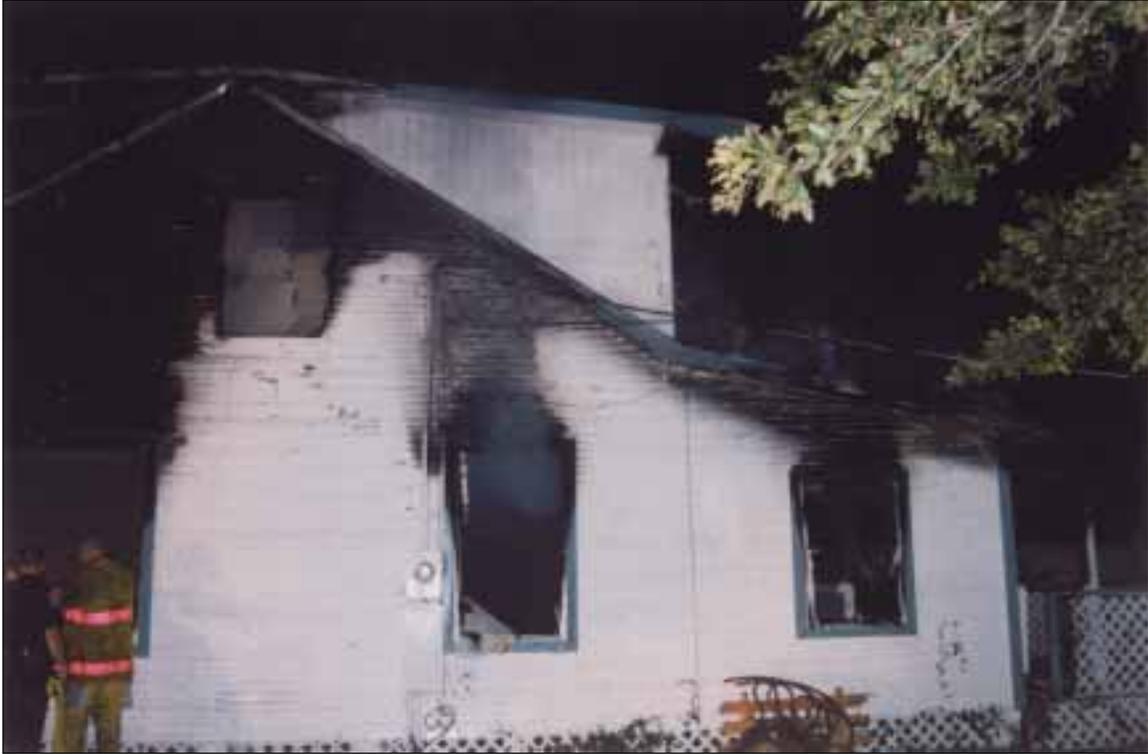
#11 Night view of southern wall; again pattern of exterior side indicative of former enlargement of second floor

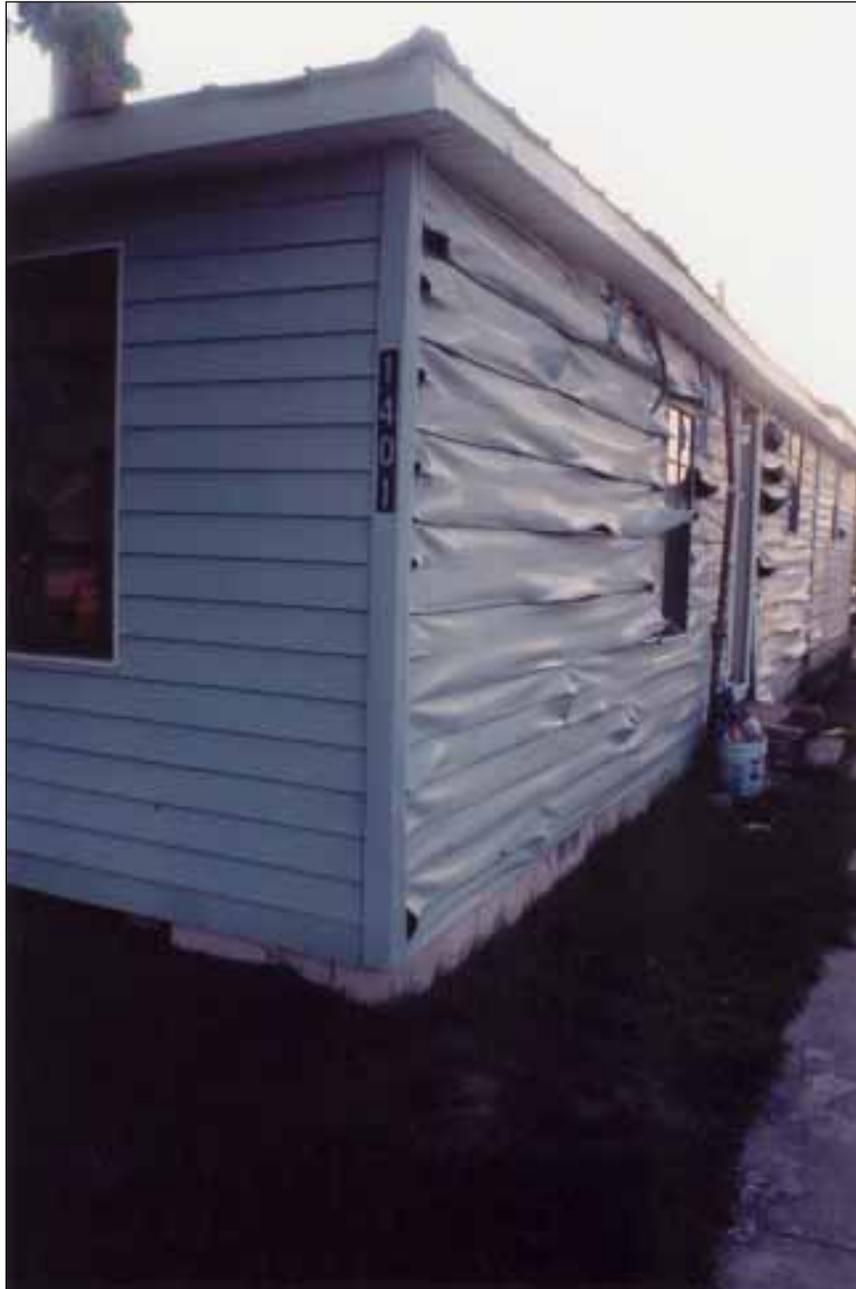
#12 Northern exposure; note melting of exterior vinyl siding

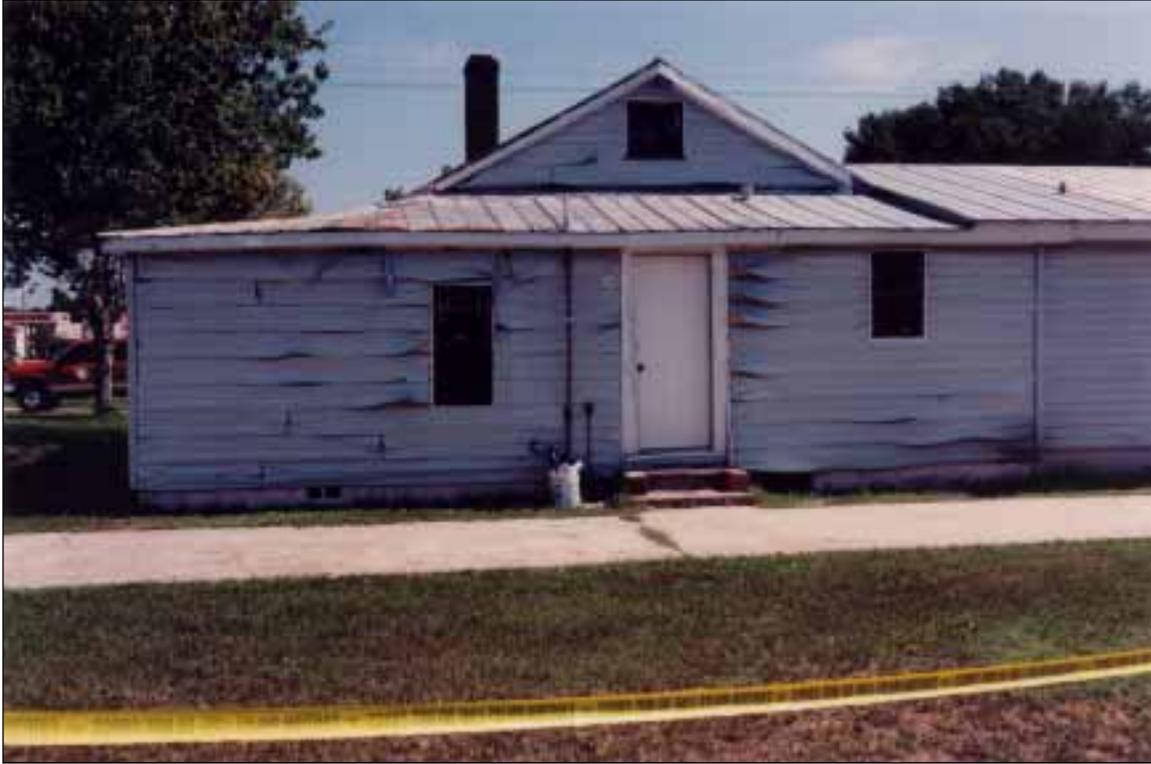
#13 Northern exposure; note melting of exterior vinyl siding

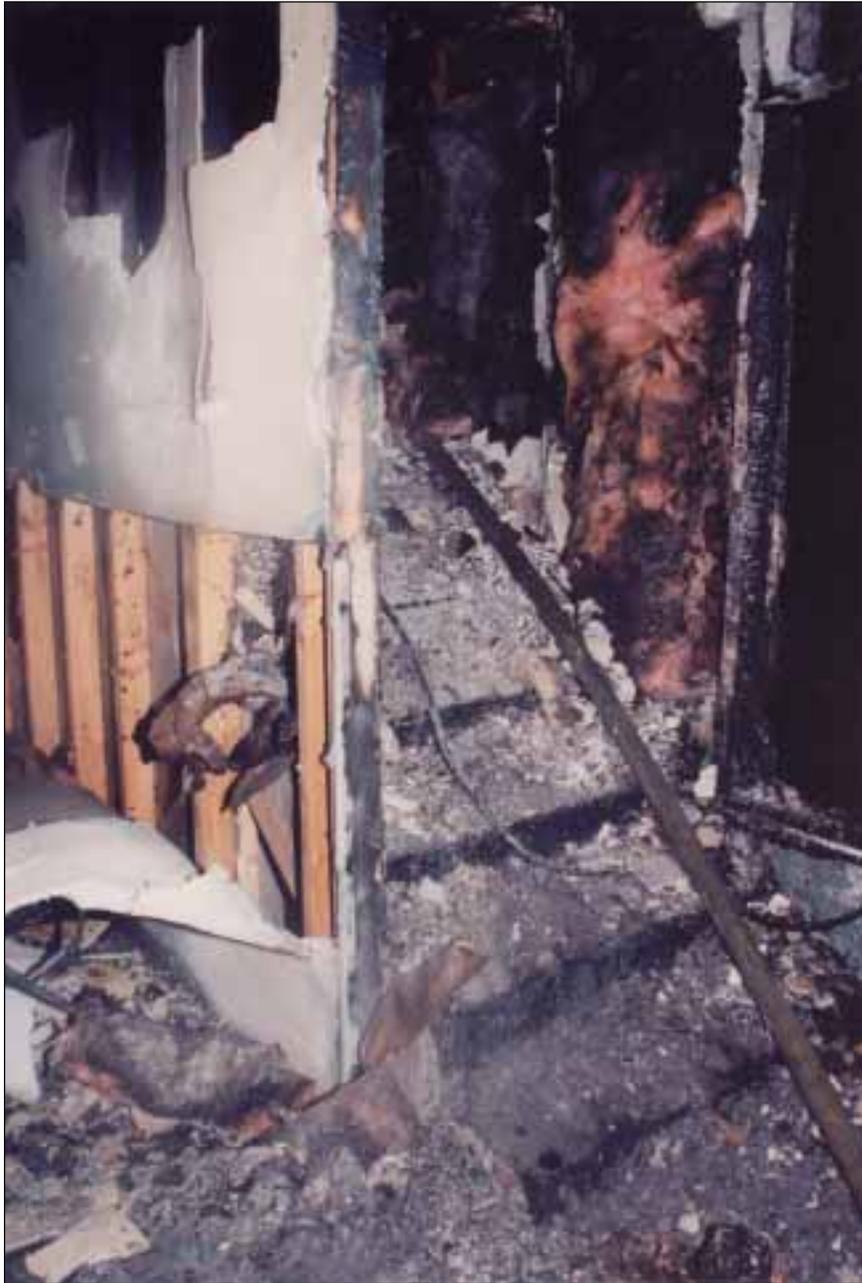
#14 Hose line extending up interior stairwell; note accumulation of debris

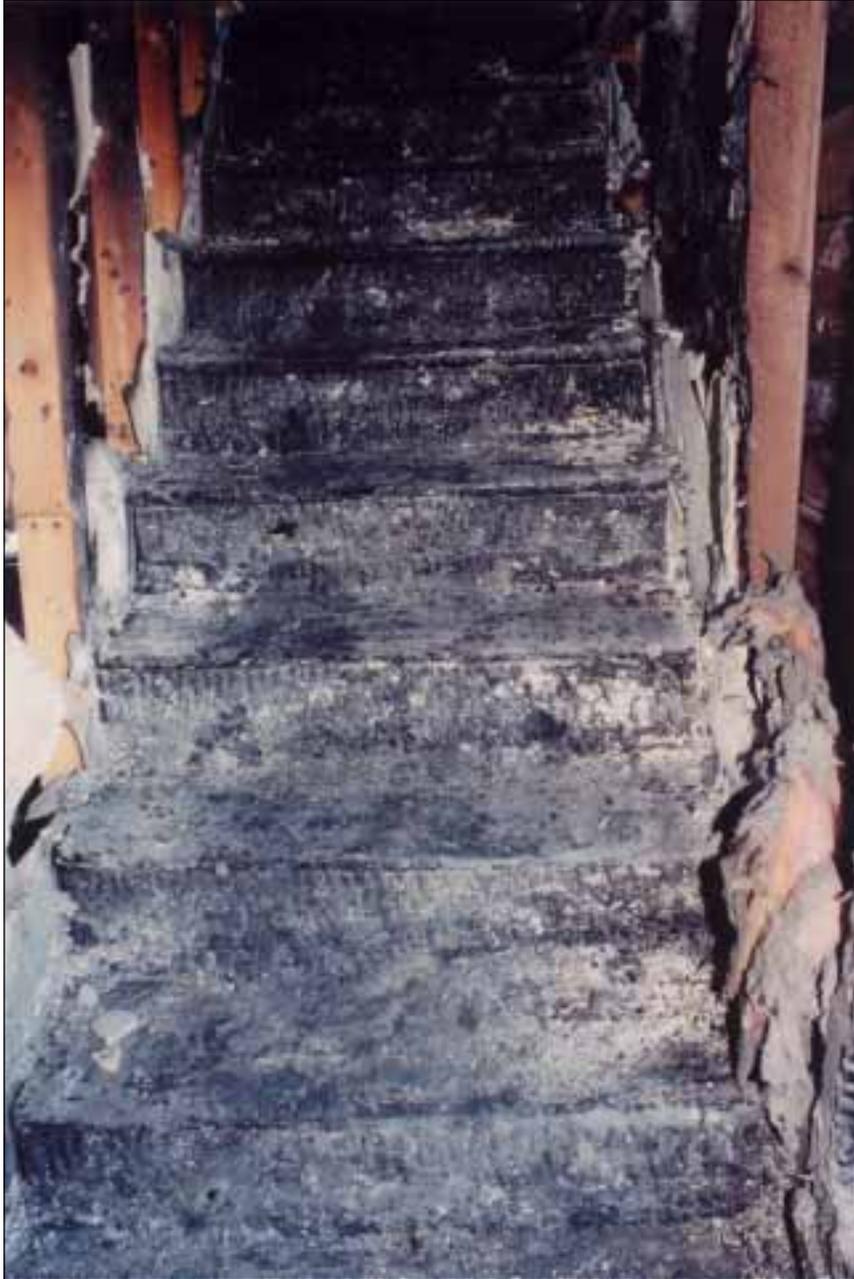
#15 View up the stairs from first floor; note deep charring on stairs

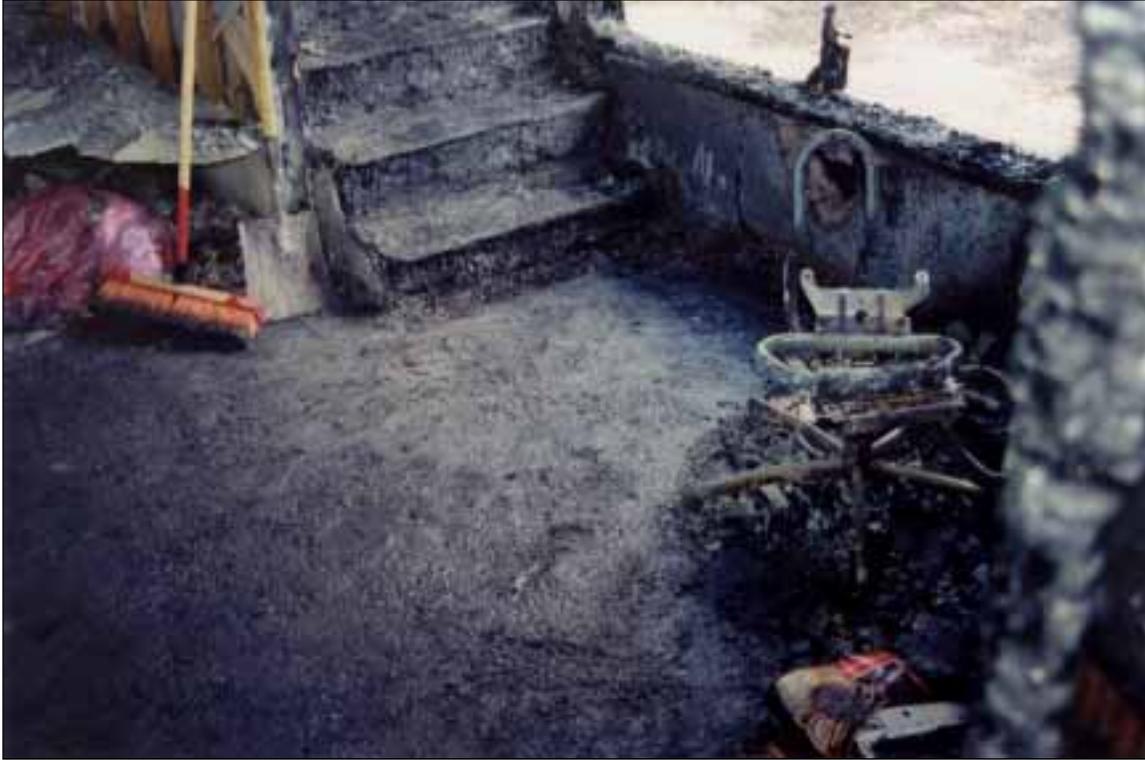
Firefighters began to exhaust the contents of their first bottle of air and backed down the stairs at which point they were advised by the officer of the Engine 201 that there was an additional victim at the base of the stairwell, bringing the total victims to five. The body had been difficult to recognize due to severity of burns.

#19 Day time view of base of stairs, which has been cleaned to the floor. Fifth victim was discovered at this location by Engine 201

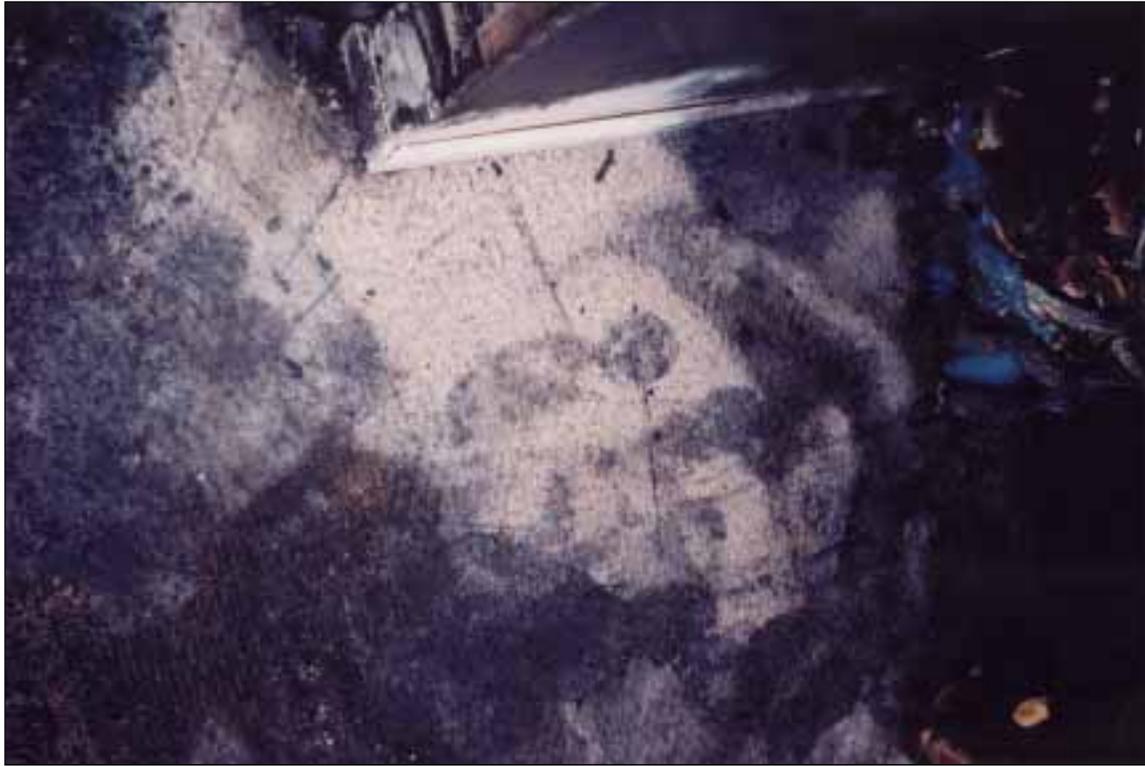
#21 Location of victims one and two (ultimately six) just inside landing of stairs on second floor, note lack of burns and smoke pattern on carpet

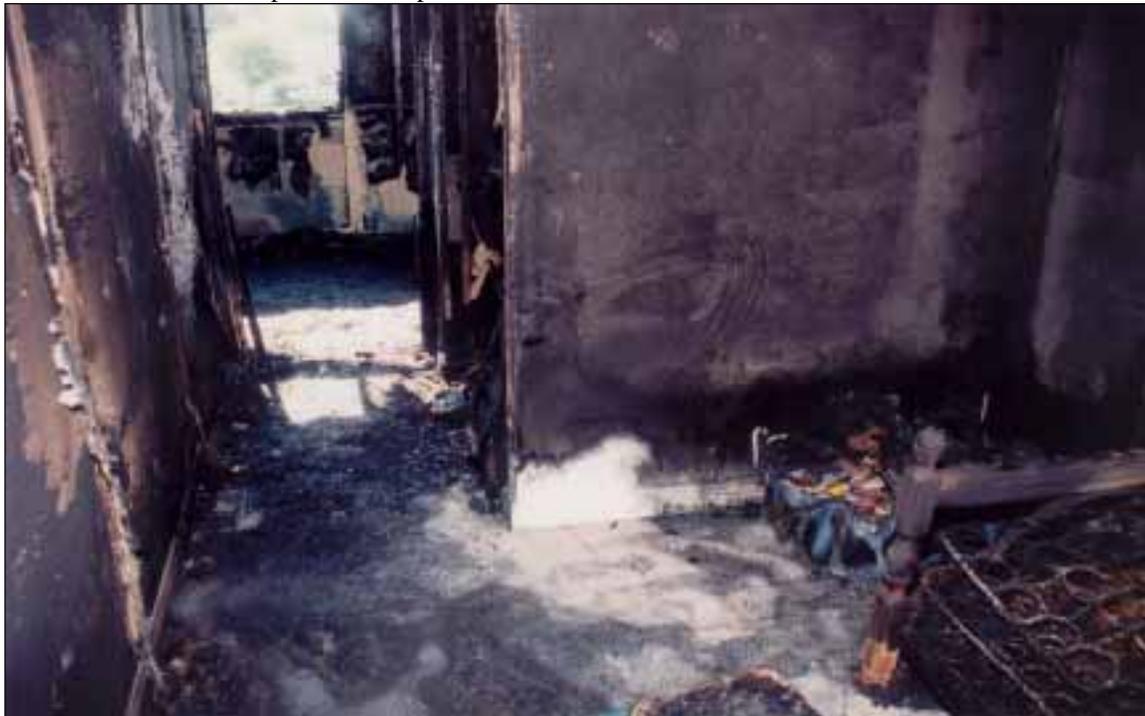
#22 Additional view of victims one, two, and six; note lack of burn/smoke on baseboard due to adult female's head coming to rest against wall

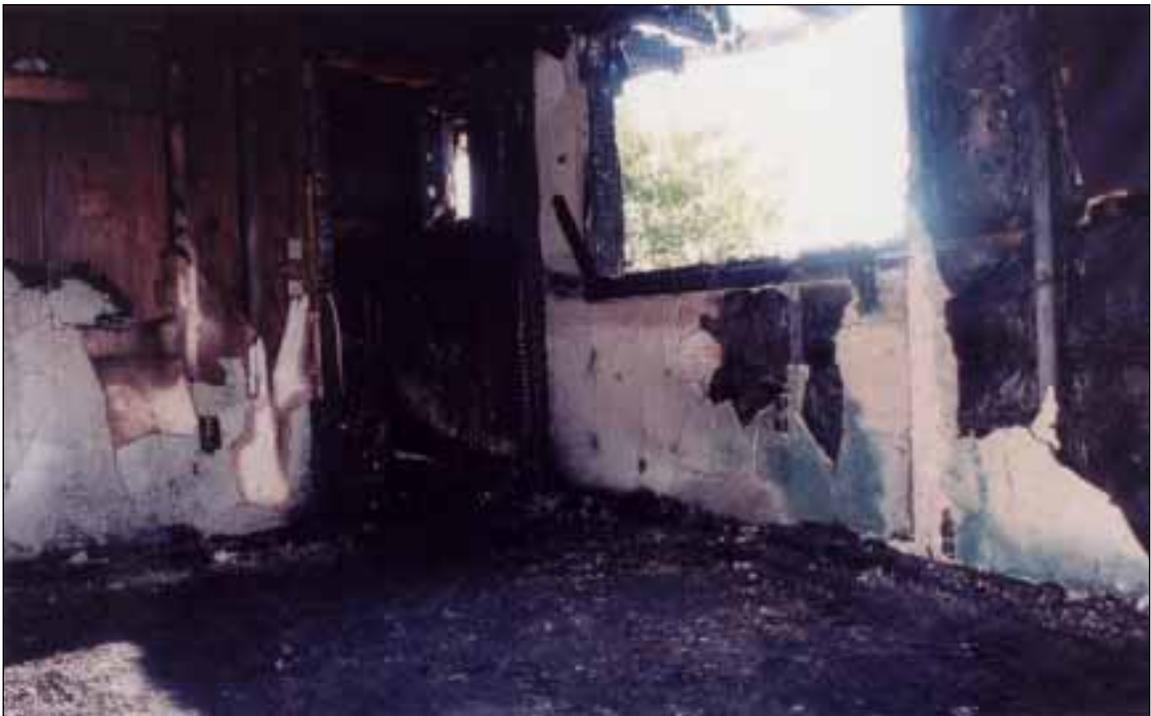
#24 View of rear window on east side alleged to be broken by male survivor; victims three and four found just inside the window

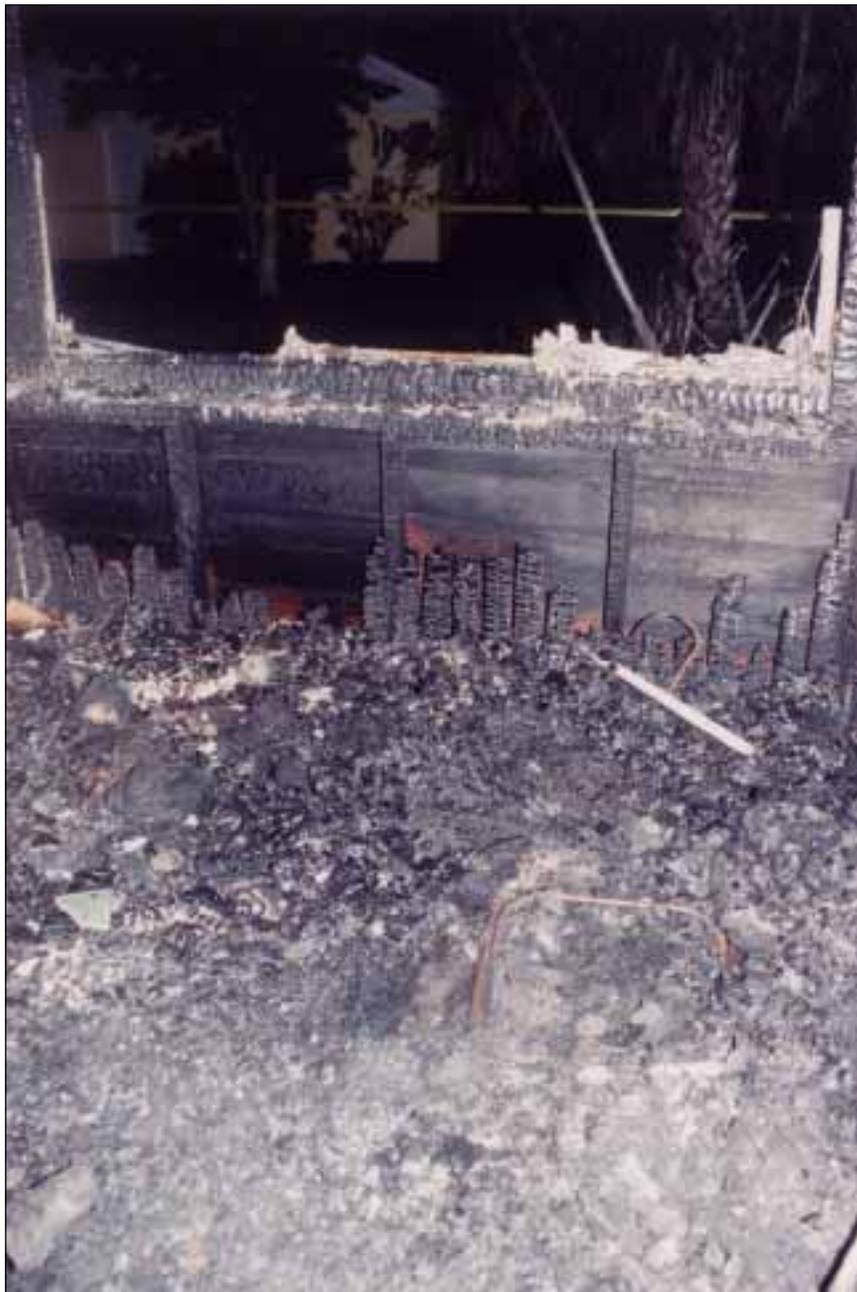
Investigators determined that a battery charger had been left plugged into an electrical outlet on the enclosed front porch of the dwelling and had caused the fire. The battery charger was not in use at the time of the fire, but had been covered by clothes and apparently overheated, igniting the blaze.

#28 Point of origin on front porch

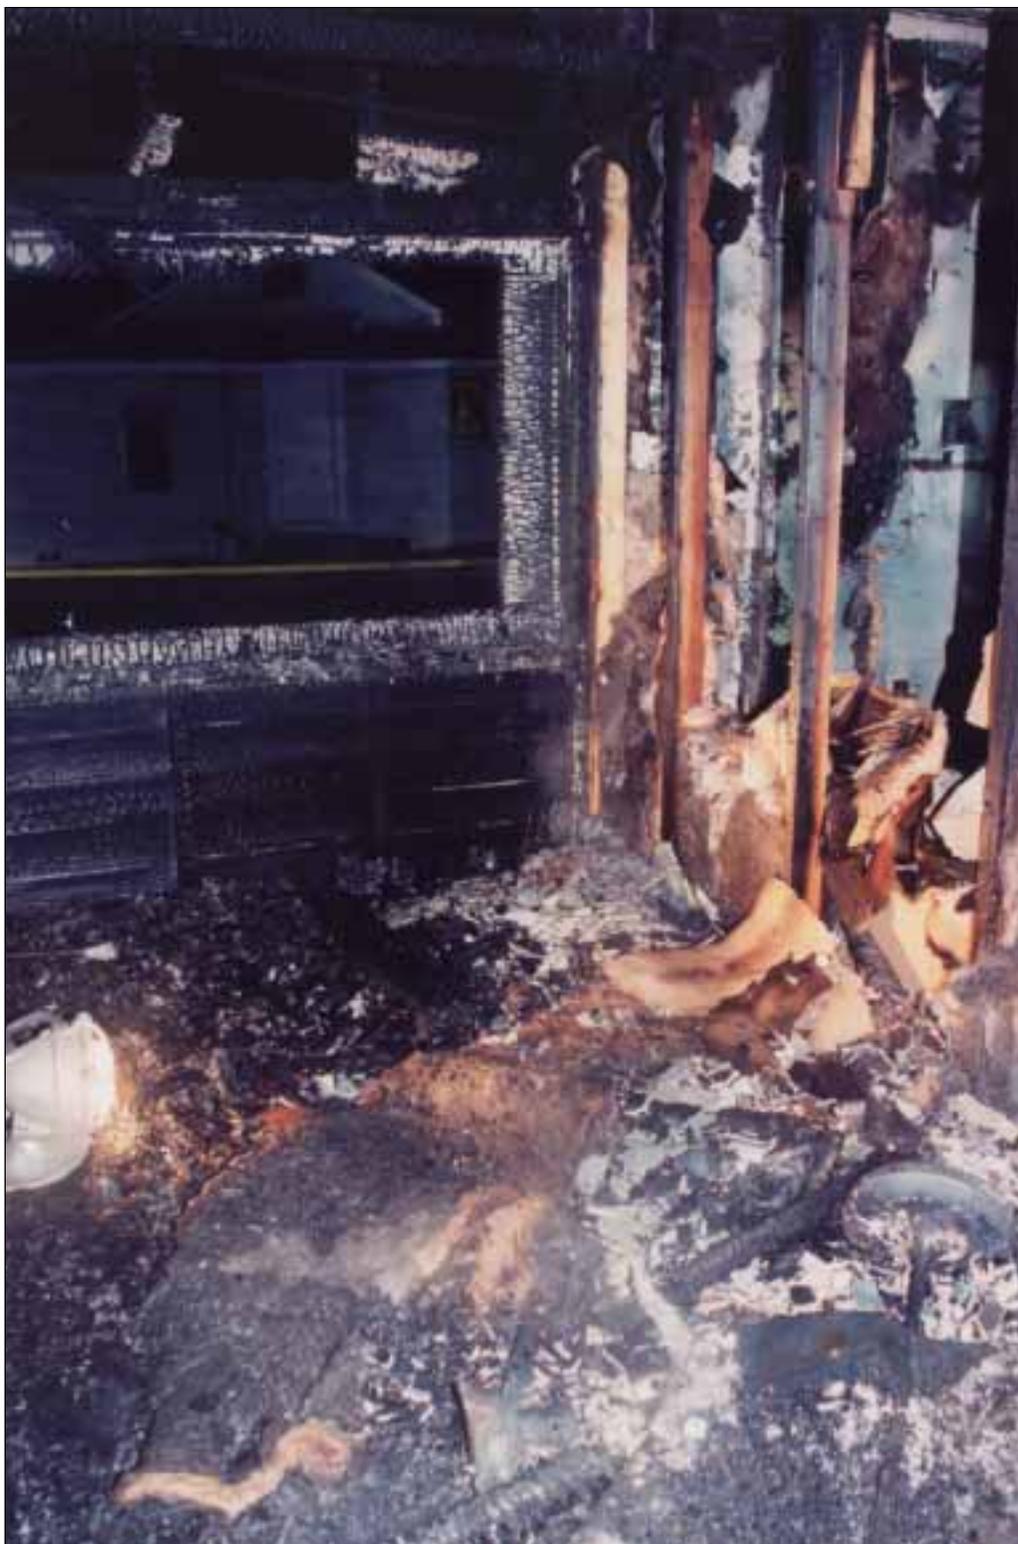
#29 Debris at point of origin. Window on left.

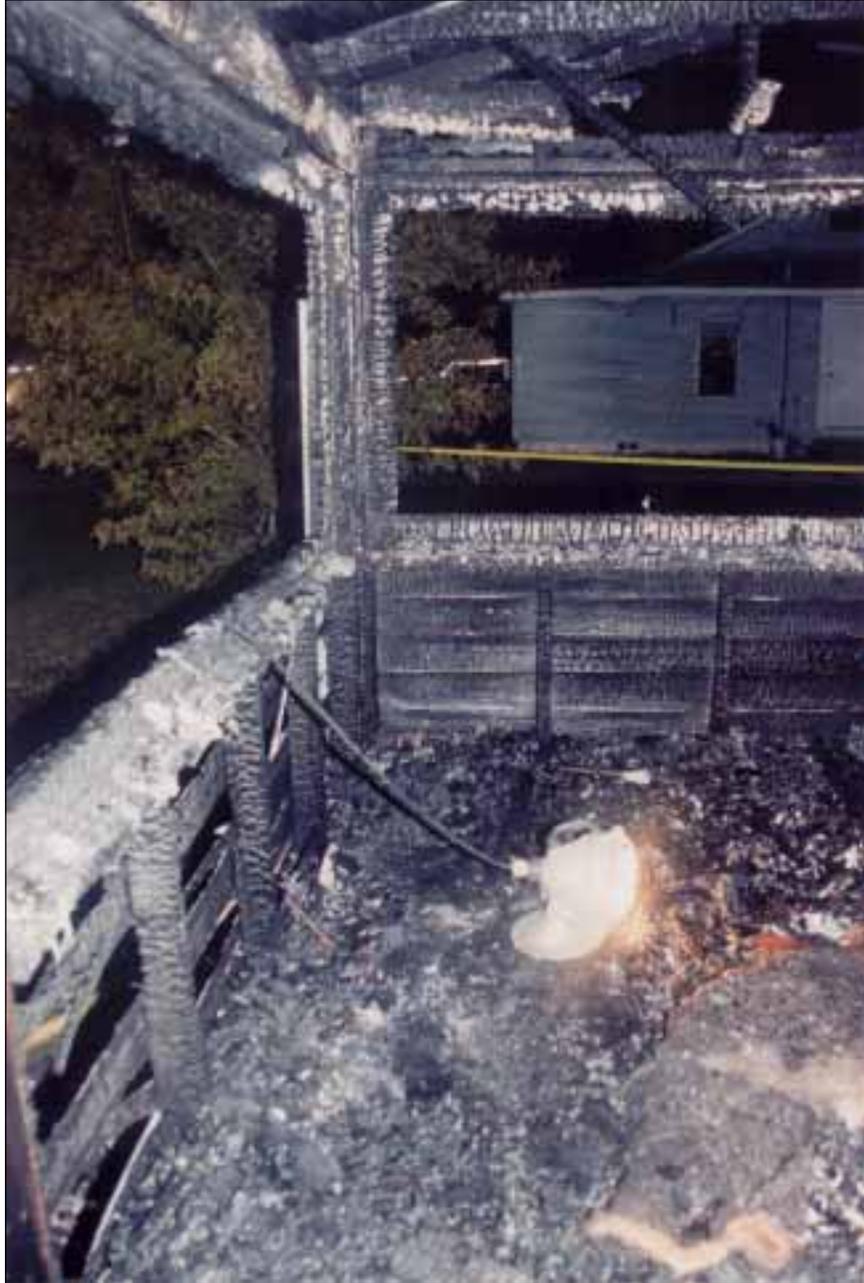
#30 Northwest corner of front porch; note debris

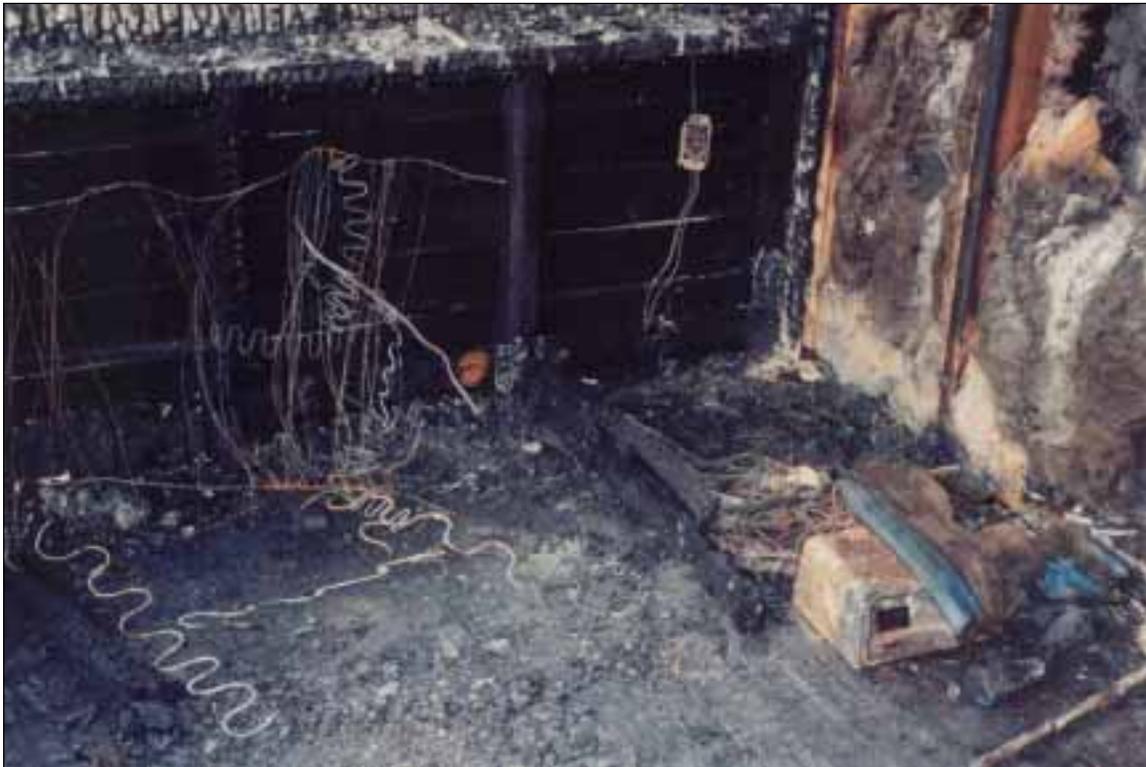
The fire was investigated by the state fire marshal's office and the St. Cloud fire and police departments. After ruling out all other causes, including possible criminal activity, investigators concluded that the fire was caused by a battery charger (see photos, page B26) that had been left plugged in to an electrical outlet on the front porch. The battery charger had not connected to anything at the time of ignition, but had been covered by clothes, which apparently overheated and then ignited.

#31 Electrical outlet and battery charger at point of origin

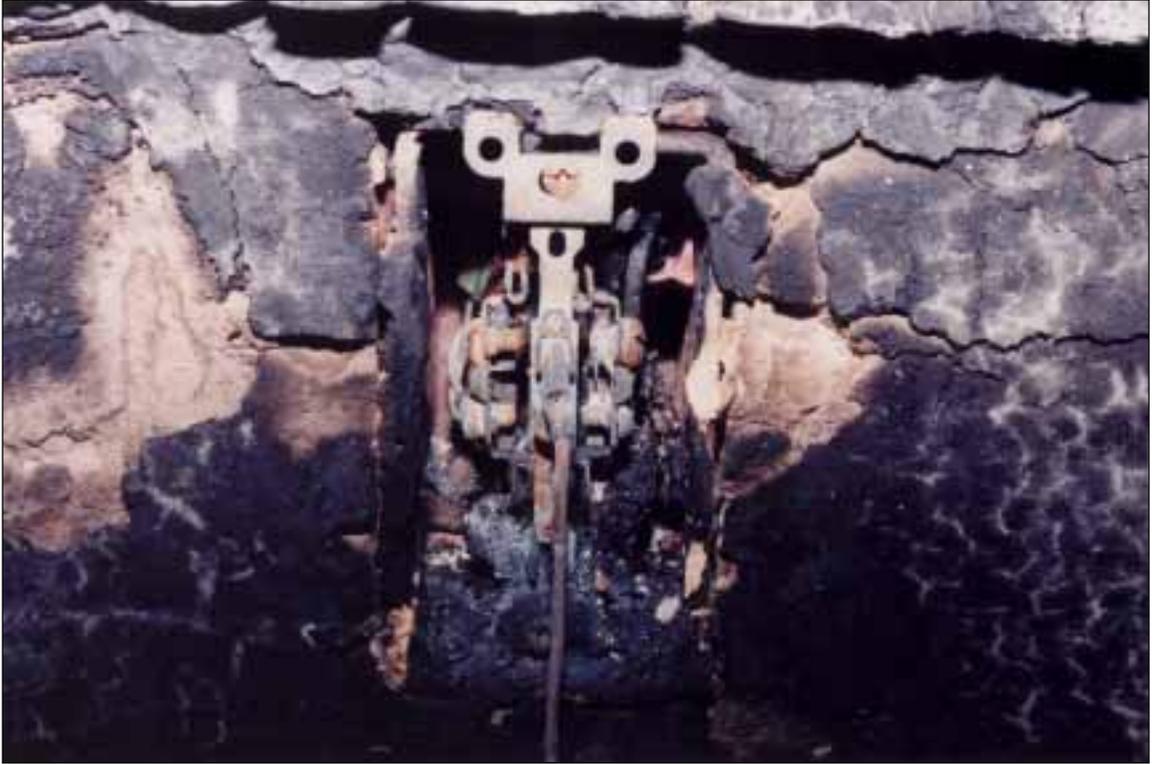
#35 Electrical outlet with battery charge still plugged into the outlet

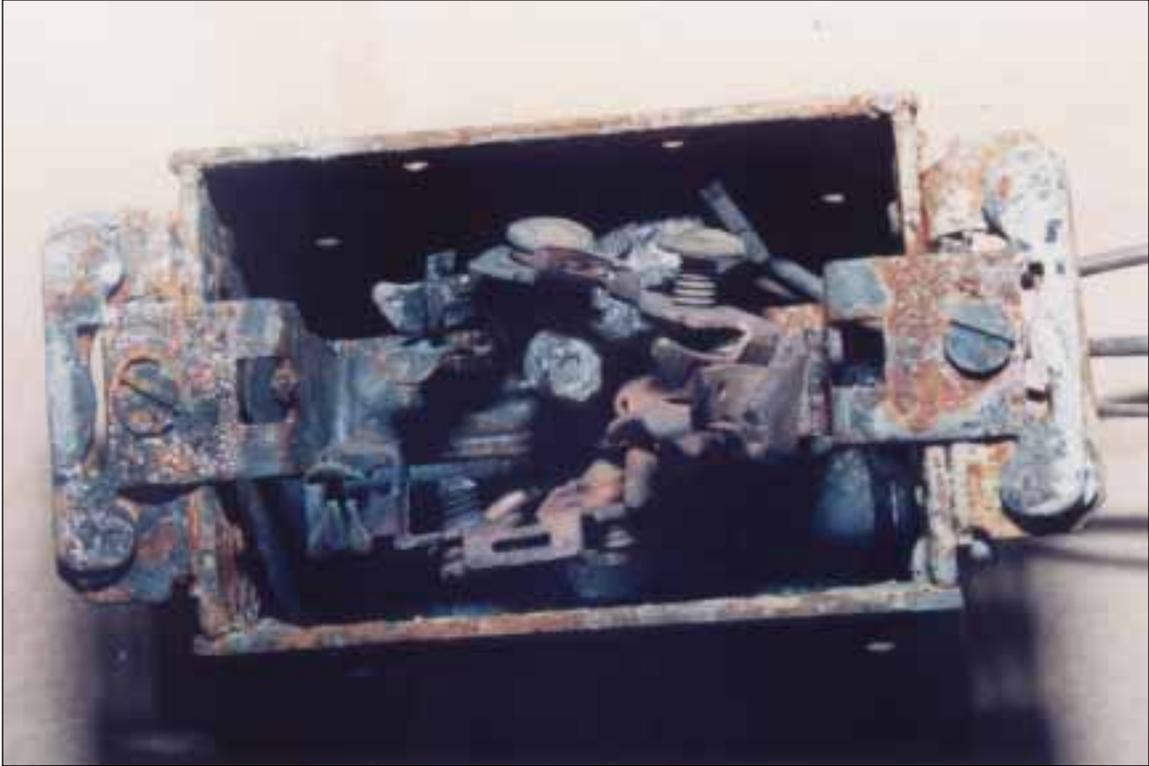
#37 Close-up of the outlet, with plug still in tack

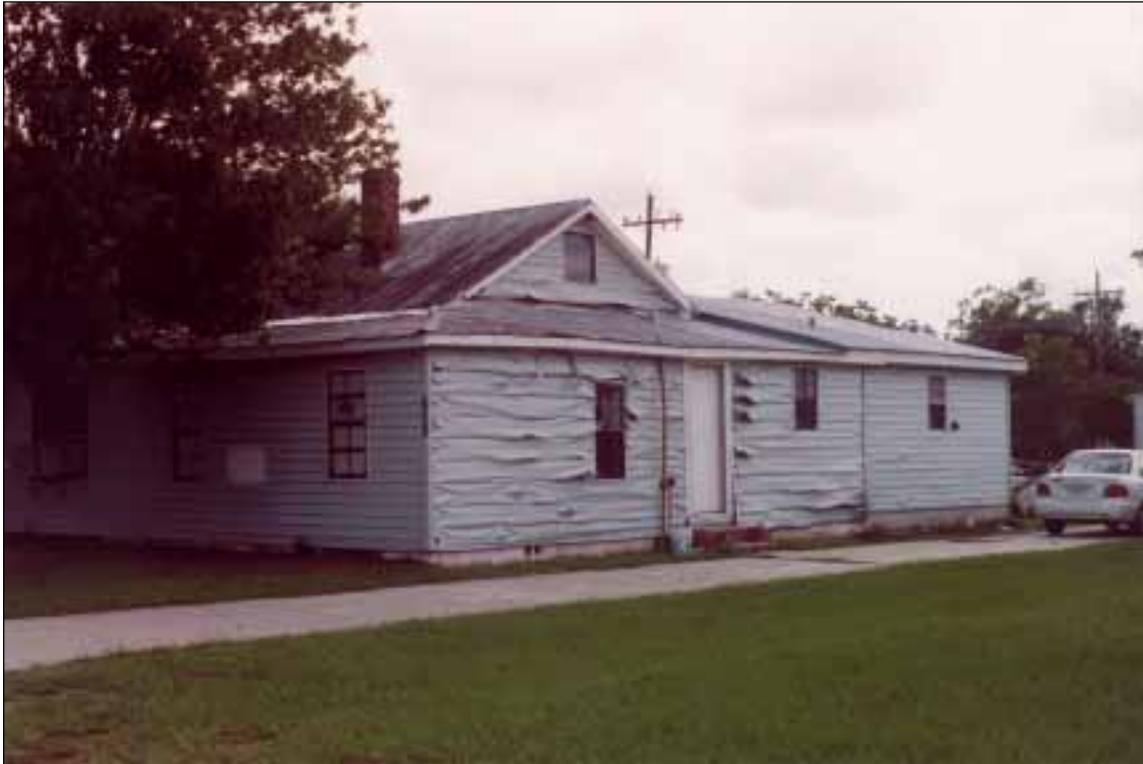
#44 North exposure: note melted siding
