# **Fire at Watts Bar Hydroelectric Plant**

**U.S. Fire Administration**

### **Major Fire Investigation Program**

This is Report 147 of the Major Fires Investigation Project conducted by Varley-Campbell and Associates, Inc./TriData Corporation under contract EMW-97-CO-0506 to the United States Fire Administration, Federal Emergency Management Agency, and is available from USFA WEB Page at <http://www.usfa.fema.gov>.

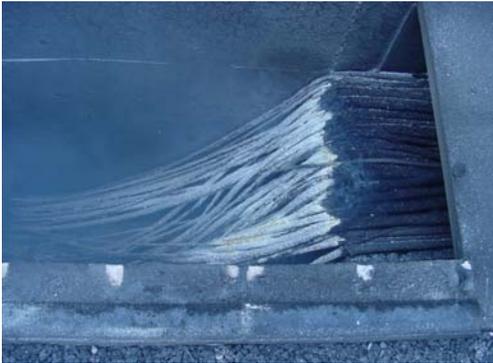
*Burned cables, running from the cable tunnel to the switchyard*

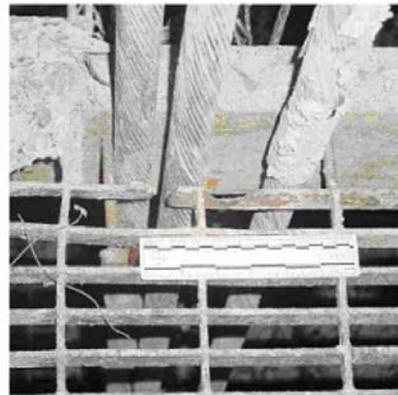
Based on damage to the cables and the steel decking, investigators concluded that prolonged rubbing of the steel decking against the butyl rubber insulation on the cable had resulted in a breaching of the cable insulation at the number five level (roughly 60 feet above ground) in the cable shaft. This resulted in an arc from the cables to the decking, and back to the cable. The extreme temperature generated by this arc was enough to cause a small amount

*Point of fire origin*

of the insulation to deteriorate into a flammable substance, thereby resulting in ignition. The large quantity of flammable materials in the shaft, coupled with a continuous chimney effect, provided the small fire with enough fuel to self-sustain and free burn. Within a matter of seconds, the fire started to spread rapidly. The high flammability of the insulation surrounding the cabling magnified the speed of propagation. Those cables which were covered with PVC released polyvinylchloride gas as they burned.

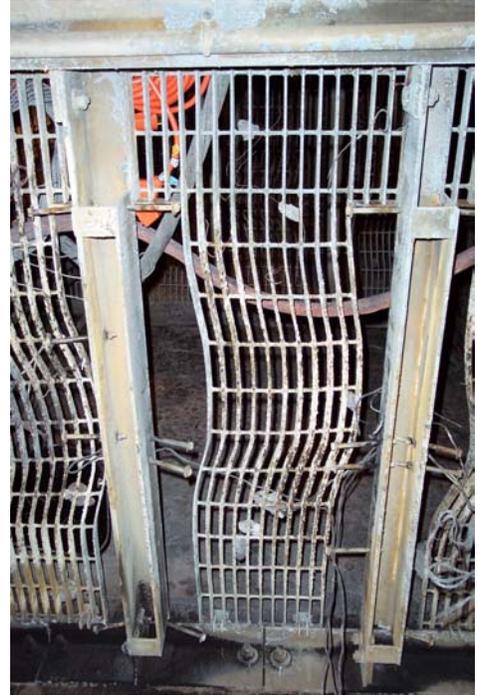
the fire. The heat generated in the shaft was so intense that steel decking 60 feet below the area of origin was severely warped, while water used during the first hours of attack instantly boiled on the floor of the structure or turned to steam.

*Warped decking below the area of origin*

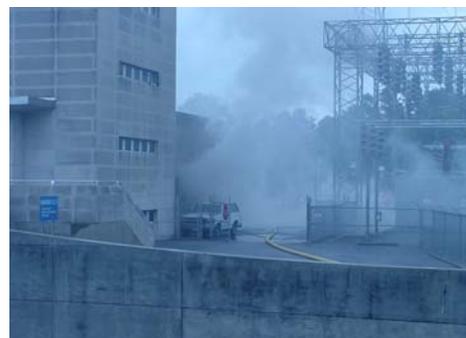
*Control Building, approximately two hours into the fire*

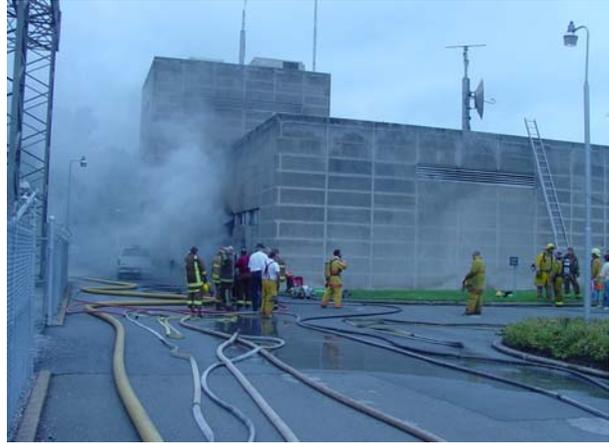
The Watts Bar Hydroelectric plant was constructed of concrete and steel, and located directly on the Tennessee River. The plant was essentially a bunker, with very few windows on the powerhouse floor, and small, sealed, windows in the lower levels of the control building. Even the large plate-glass windows located on the control room level of the control building were unable to be opened; their purpose was simply to provide a view of the dam for visitors. The building was comprised of various levels, connected by one staircase on the western side of the building. The layout of the building, combined with the limited number of windows, made it a difficult structure to ventilate.

*View of the control building from the South. Note the solid concrete construction and lack of windows.*

The construction of the hydroelectric plant contributed to heat build-up and distribution. The concrete walls, floors, and ceilings acted as an oven, intensifying the heat and trapping it in the building. These conditions made firefighter entry and fire suppression extremely difficult. During fire suppression activities, firefighters reported that the water they were using to fight the fire was turning to steam or boiling upon contact with the floor. The level of heat in the building was further evident during the post-incident investigation. Investigators found heavy spalling in the cable spreading room.

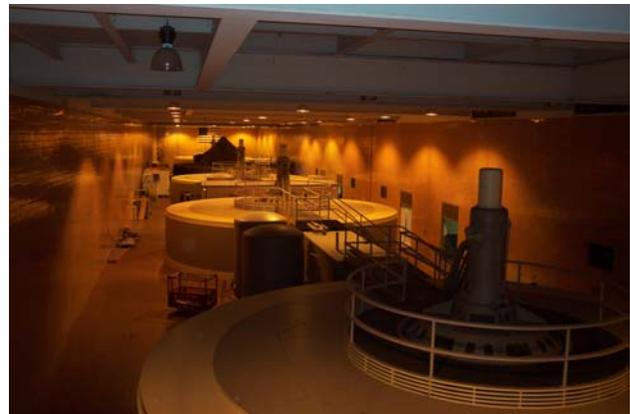
The design of the powerhouse also contributed to existing problems. The building is a large windowless structure, with heavy machinery and other dangers located throughout. It, too, has very limited means of egress, with exits to ground level on the west end and an exit to the top of the dam on the east end. The powerhouse has several levels, both above and below the waterline, with exits located on only one level. When power to the building was lost, workers were plunged into complete darkness. Personnel would have had to rely on their knowledge of the building and their sense of touch and hearing to exit the building. Luckily, a supervisor on the floor had a flashlight, and was able to find people and lead them safely from the building. TVA's review of life safety issues will likely include increased exit lighting per NFPA 101 7.8.1.

*Powerhouse floor*

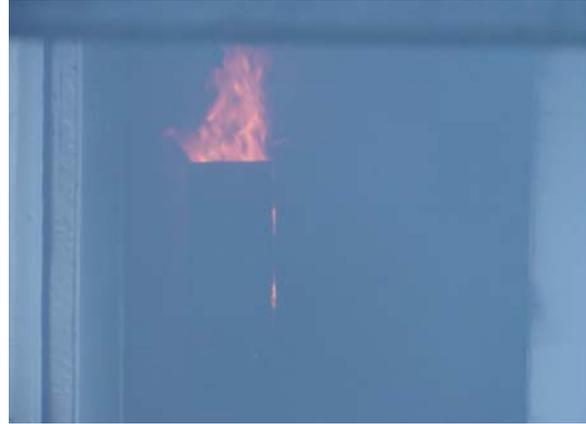
*Fire in the breaker panels; looking from outside the Control Building, three hours into the fire.*
