# Concept Sciences Incorporated

**Hanover Township, Pennsylvania**

February 1999

## **UNITED STATES FIRE ADMINISTRATION FIRE INVESTIGATIONS PROGRAM**

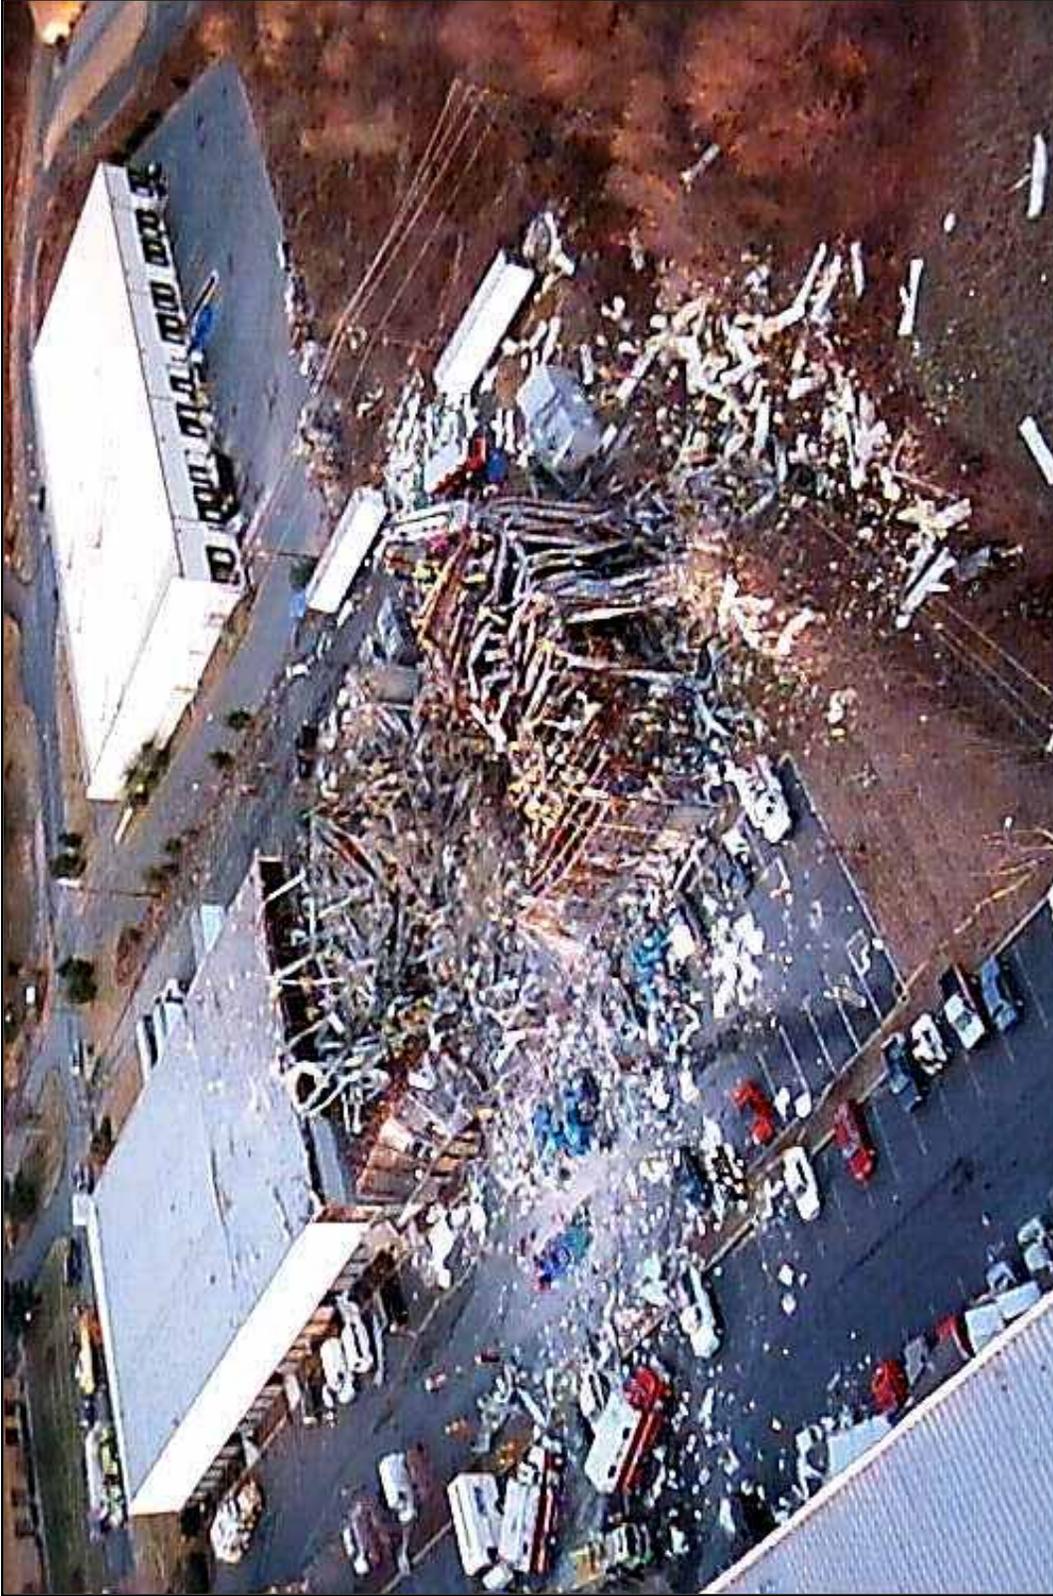
1. Aerial view of the CSI Plnat after the explosion.

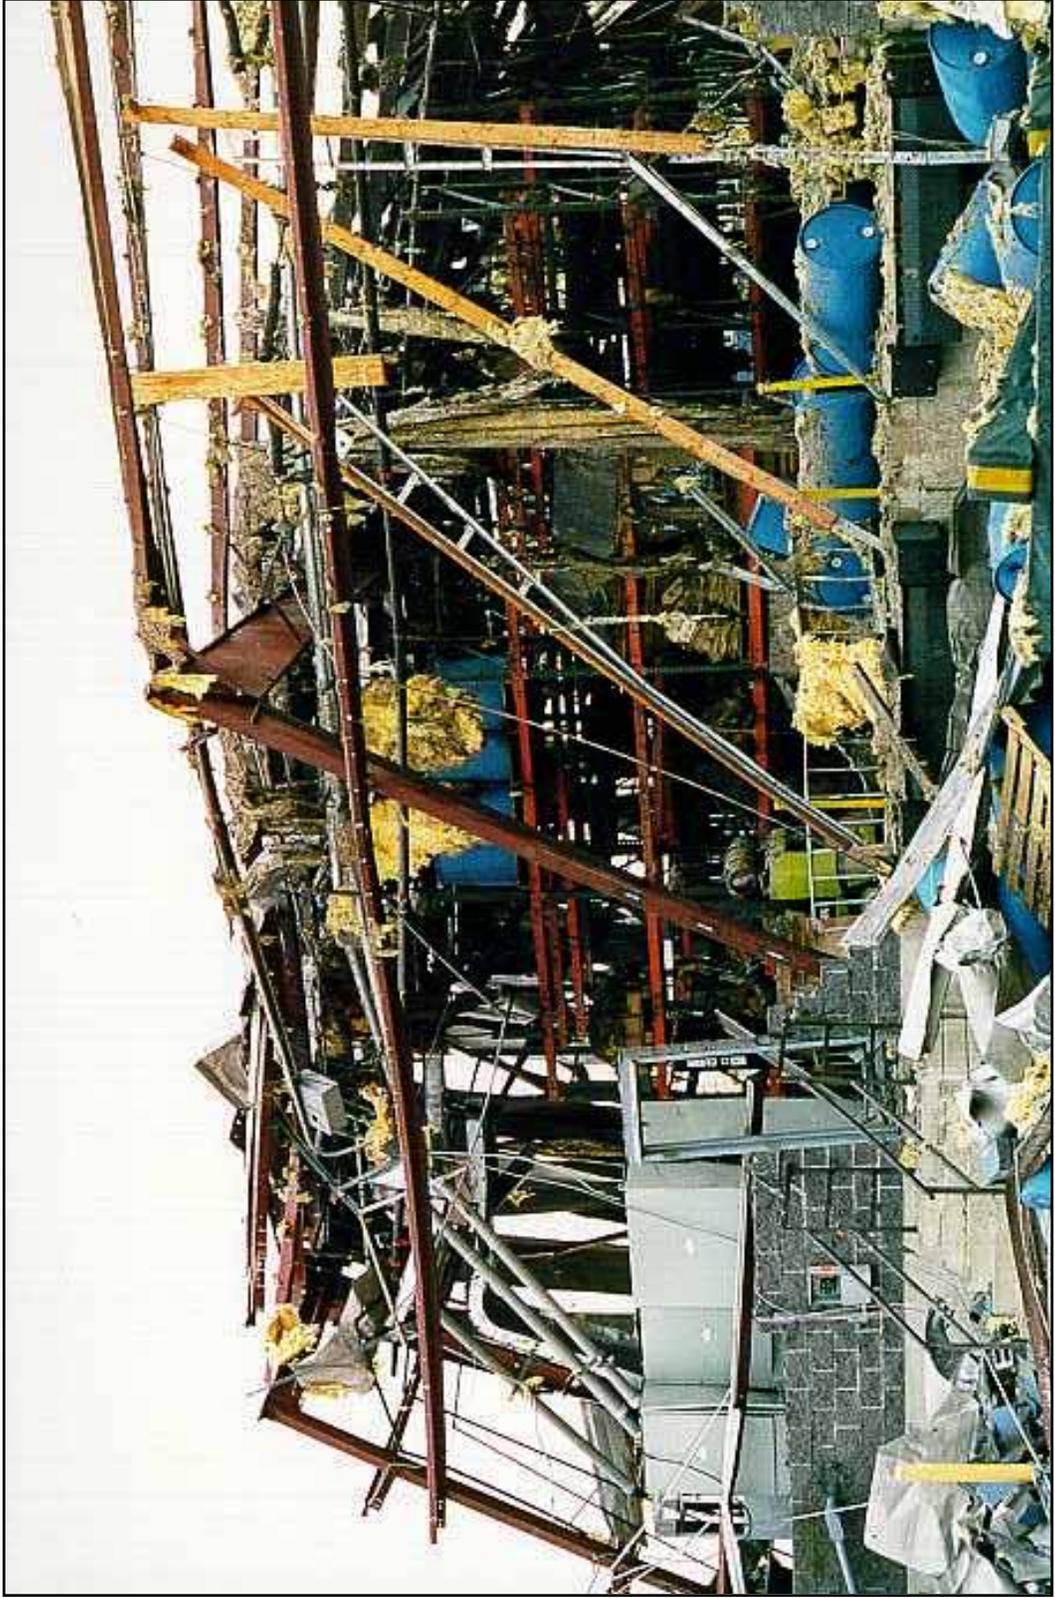
2. View of the extent of the destruction.

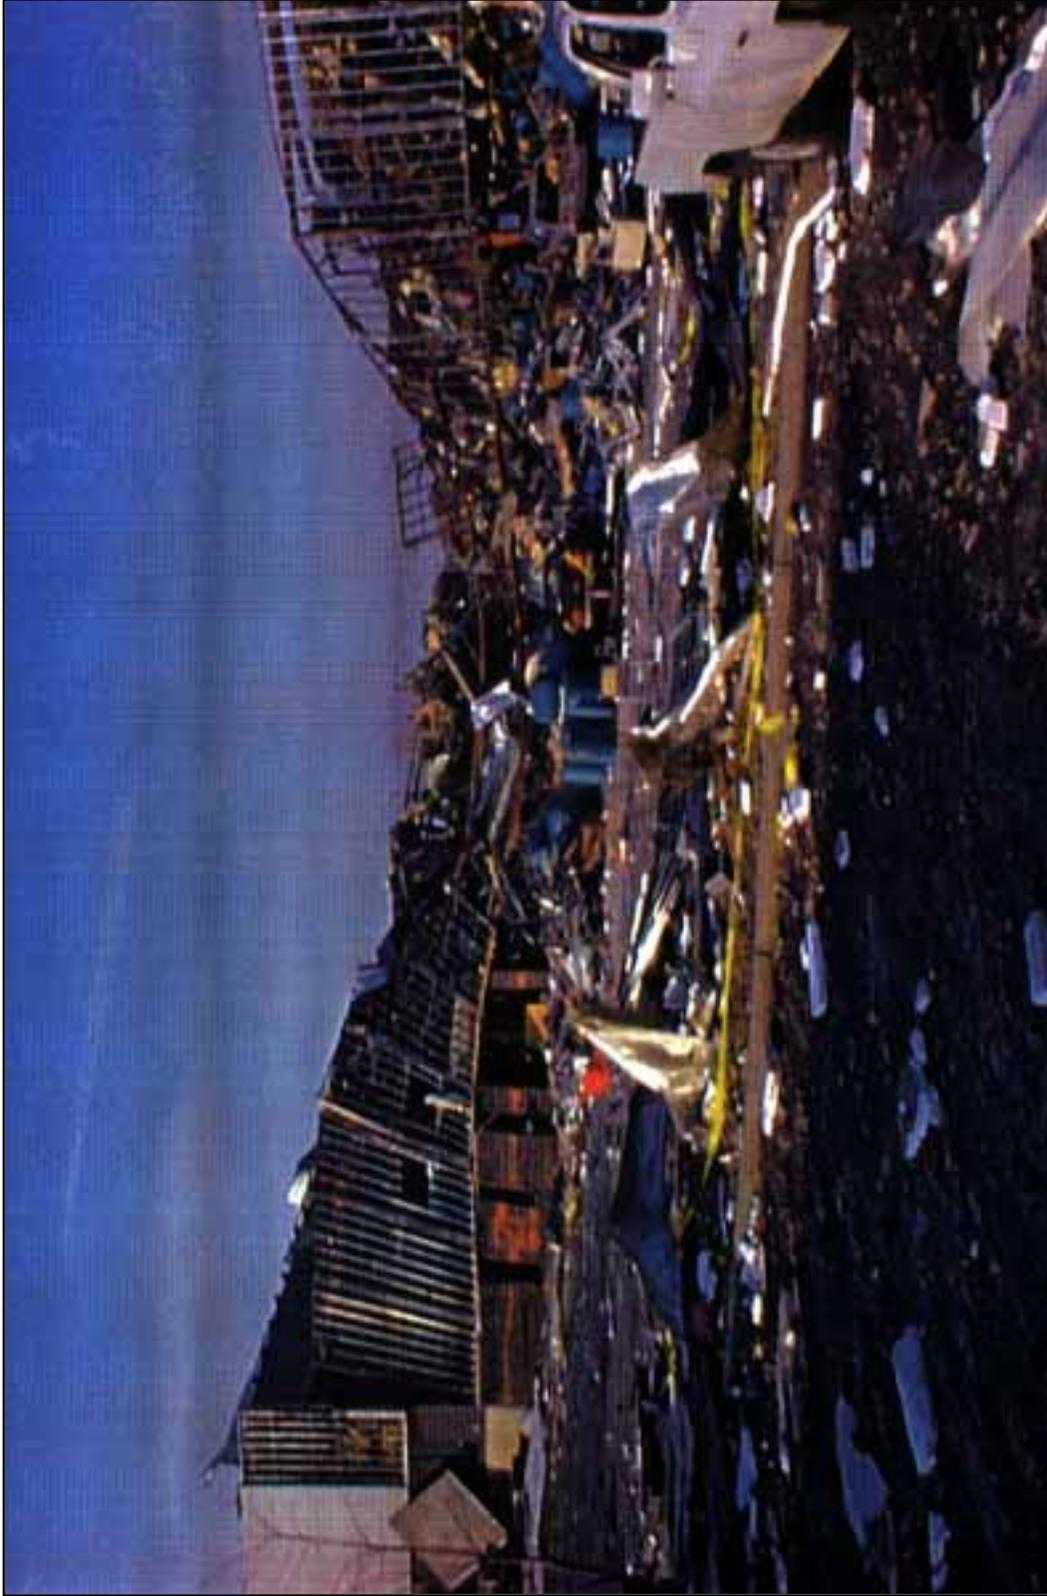
4. View of the destruction to the side of the CSI building.
